GEN-2003-006A
Impact Restudy for
Generator Modification

Published May 2020
By SPP Generator Interconnections Dept.

SUMMARY

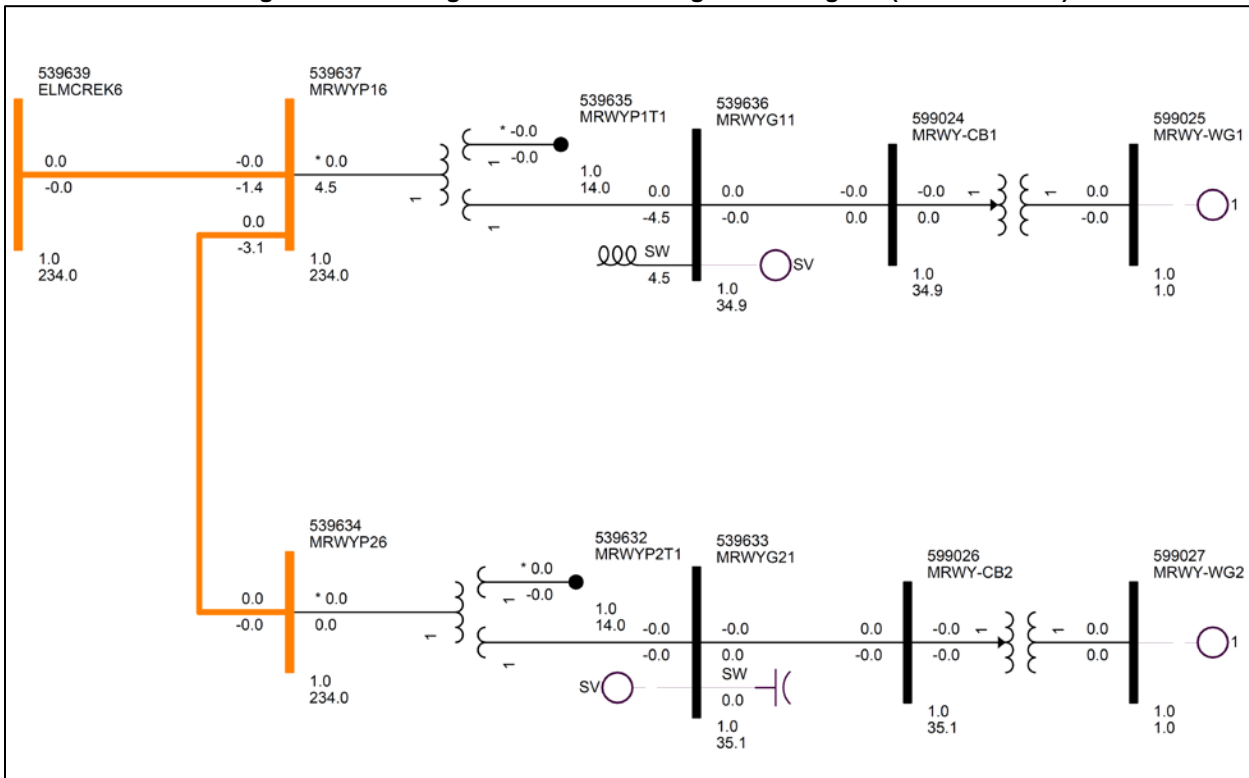
The results from the reactive power analysis showed that the GEN-2003-006A project required an approximately 9.6 MVAR (updated configuration) shunt reactor at the project substation, to reduce the POI MVAR to zero which increased from 4.4 MVAR (existing configuration). Figure 3-1 illustrates the shunt reactor size required to reduce the POI MVAR to approximately zero with the existing project configuration. Figure 3-2 illustrates the shunt reactor size required to reduce the POI MVAR to approximately zero with the updated project configuration. Reactive compensation can be provided either by discrete reactive devices or by the generator itself if it possesses that capability.

Figure 3-1: Existing GEN-2003-006A Single Line Diagram (Shunt Reactor)

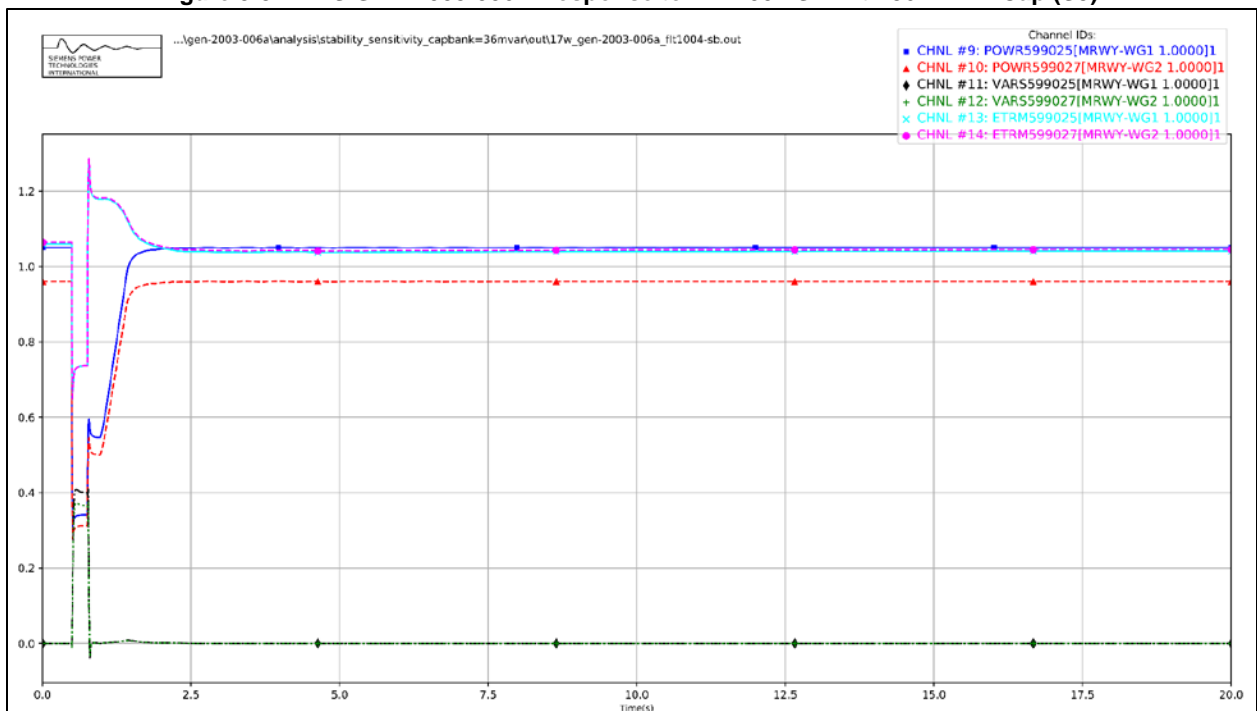
With the modification configuration, a post-event stable simulation at full output was achieved with a unity power factor by initializing the facility capacitor banks at 36 MVAR prior to the event as shown in Figure 5-3 (S3). Figure 5-1 and Figure 5-2 show that the system response is still unstable when only 12 or 24 MVAR are being produced by the capacitor banks (S1 & S2).

Figure 5-3: MRIS GEN-2003-006A Response to FLT1004-SB with 36 MVAR Cap (S3)

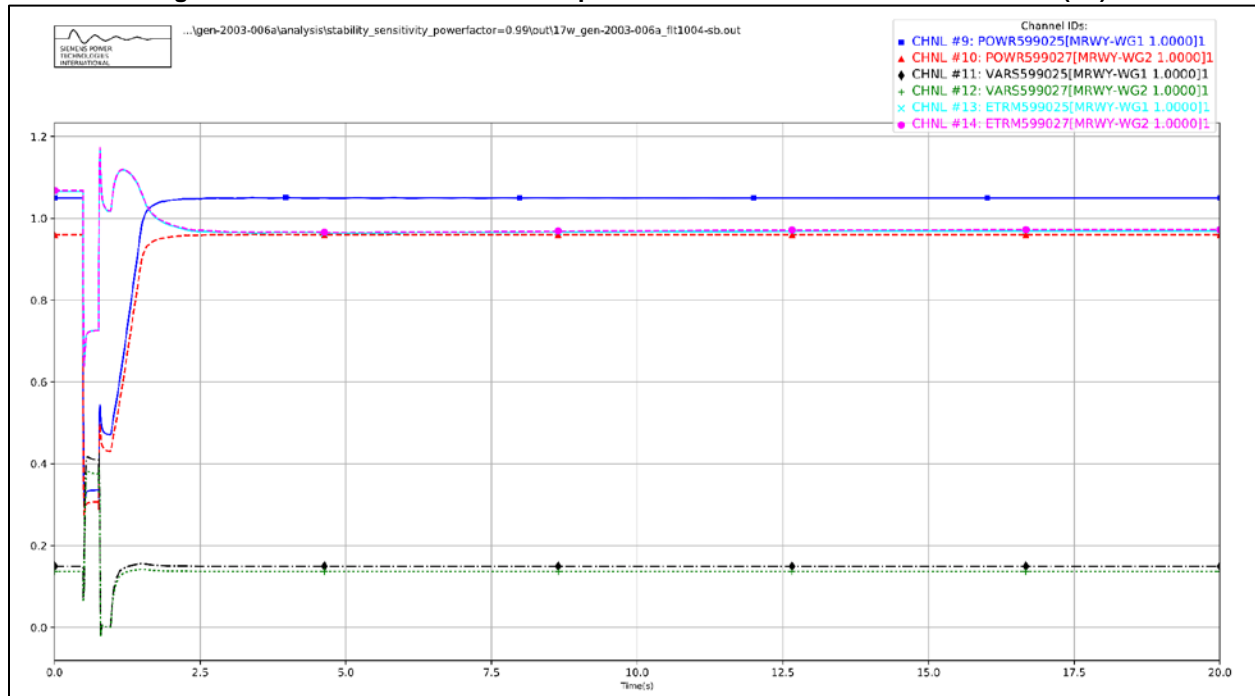
Alternately, setting the generator power factor to 0.99 or 0.98 lagging (providing vars) and with the capacitor banks offline prior to the event also resulted in a stable simulation as shown in Figure 5-4 and Figure 5-5 (S4 & S5).

Figure 5-4: MRIS GEN-2003-006A Response to FLT1004-SB with GEN PF at 0.99 (S4)

Each of these pre-event set points may result in generating facility and transmission system voltages beyond the normal operating range (typically 0.95-1.05 pu) under certain system conditions. Vendor documentation indicated that the reactive power set point could be changed using ‘ALTR’ activity during simulation through adjusting VWVAR (L+1). This adjustment during simulation could not successfully be implemented in this study using the user-written model

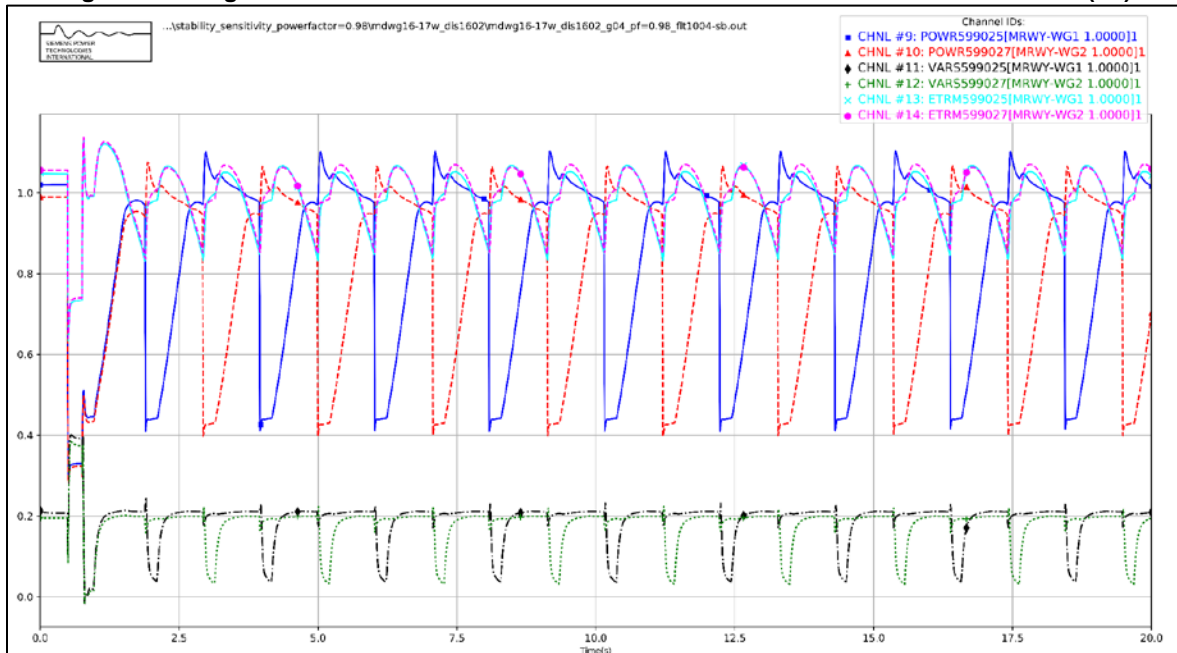
Four sensitivity cases were simulated with the existing GEN-2003-006A configuration with the STATCOM devices switched offline to understand the impact of the modified GEN-2003-006A configuration. Figure 5-6 shows that with a unity power factor and initializing the facility capacitor banks at 36 MVAR prior to the event, the response was unstable (S6). Figure 5-7 shows that with setting the generator power factor to 0.98 lagging (providing vars) and with the capacitor banks offline prior to the event the result was also an unstable simulation (S7).

Figure 5-7: Orig. GEN-2003-006A - FLT1004-SB with GEN PF at 0.98 and STATCOM Offline (S7)

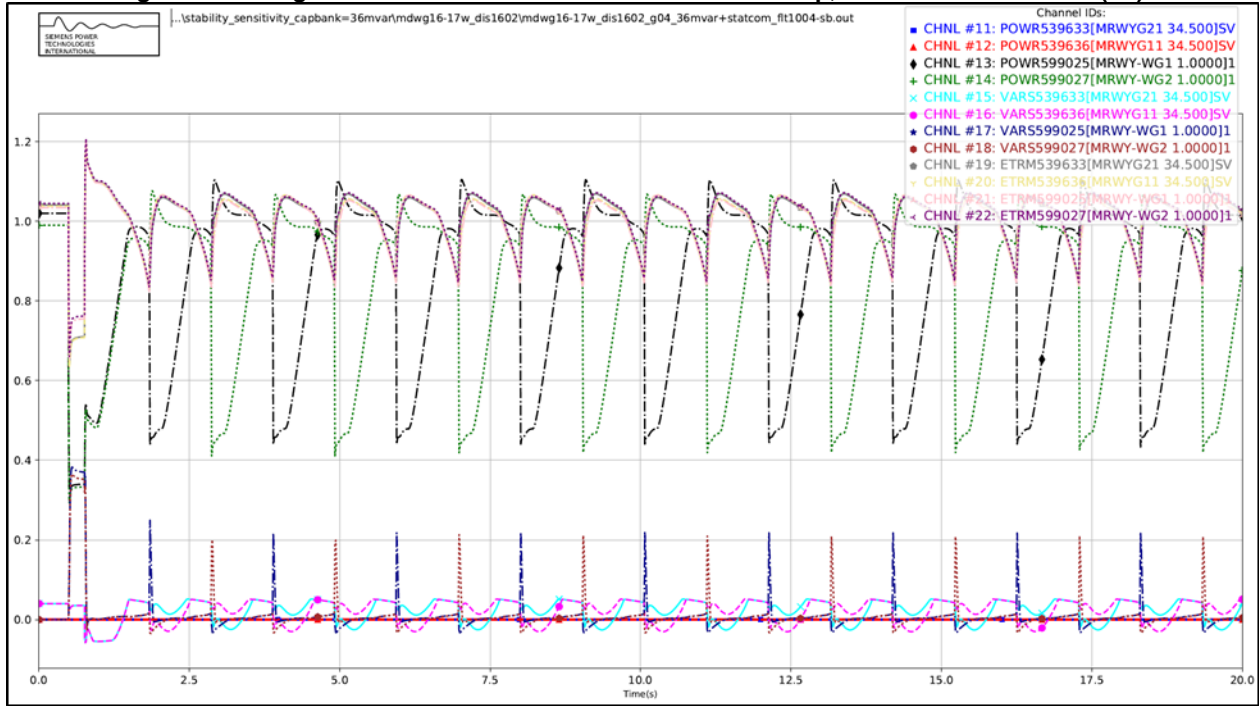
Figure 5-10 shows that with the STATCOM devices switched online, initializing the facility capacitor banks at 36 MVAR, and the generator power factor being set to unity prior to the event, the response was unstable (S9). Figure 5-11 shows that with the STATCOM devices switched online, the generator power factor set to 0.99 lagging (providing vars), and the capacitor banks set to 36 MVAR (S10A) a portion of the GEN-2003-006A generating facility protection relays tripped on high voltage. A stable simulation was found with this combination when the transformer tap points were adjusted similarly to Scenario 8 as shown in Figure 5-12 (S10). Scenario 8 and 10 show that a stable response can be achieved if the capacitor banks are dispatched at 36 MVAR, the generator power factor is at least 0.99, and the transformer tap points are adjusted regardless of the STATCOM status.

Figure 5-10: Orig. GEN-2003-006A - FLT1004-SB: 36 MVAR Cap, and STATCOM Online (S9)
