***Impact Restudy  
For Interconnection Request  
GEN-2008-023***

***SPP Generation  
Interconnection Studies***

***GEN-2008-023***

***July 2011***

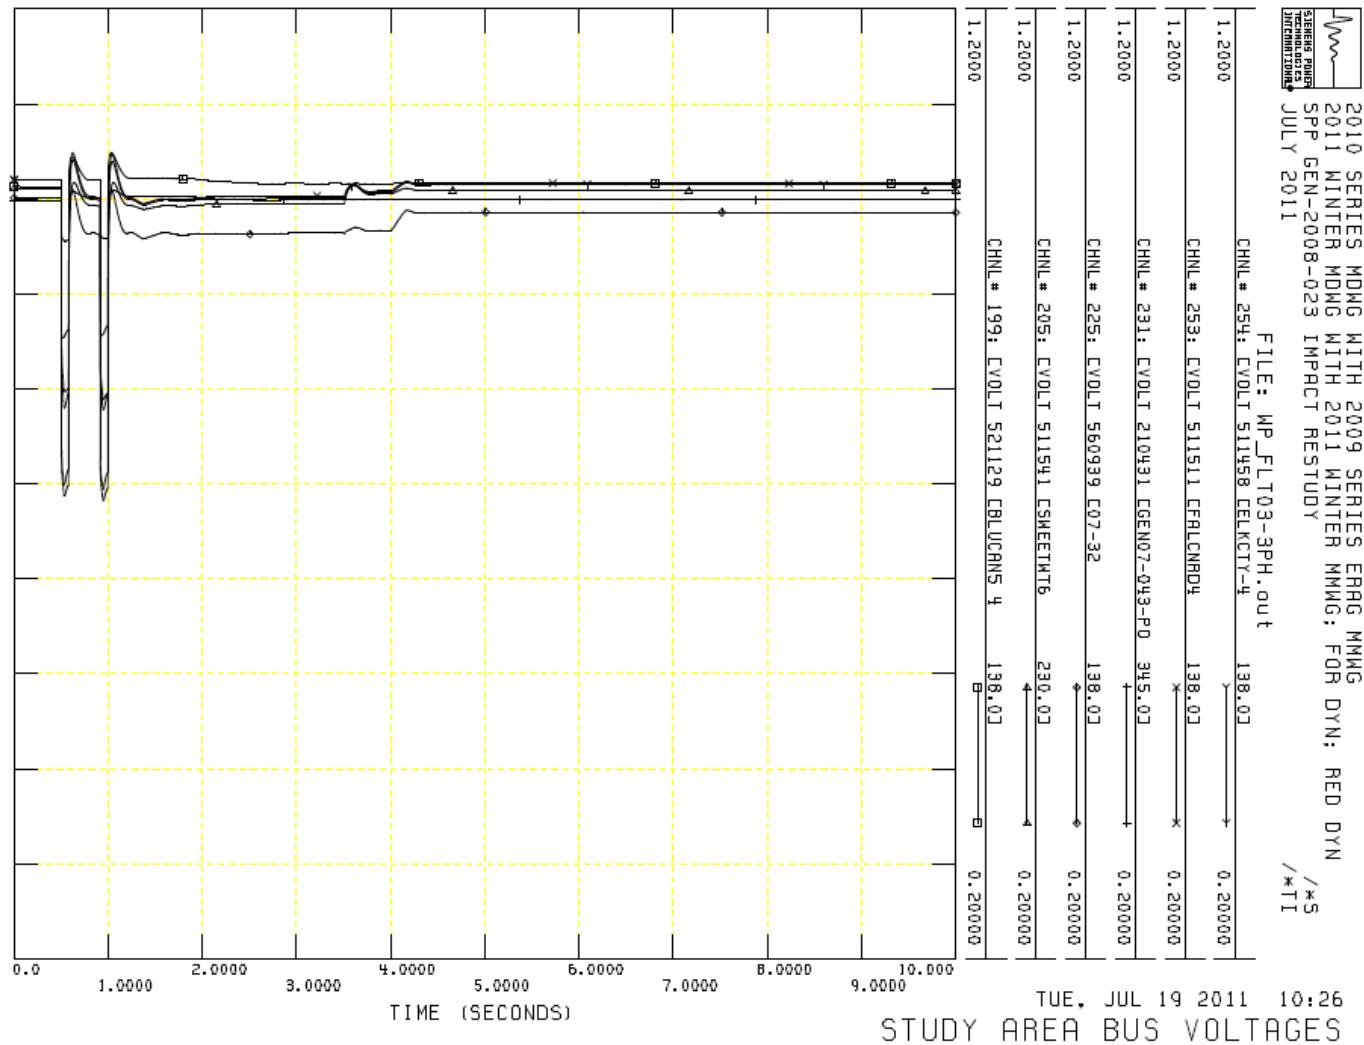
Figure 4-3. Response of selected area bus voltages for case FLT03-3PH for winter peak conditions.

Refer to Table 4-2 for a summary of the Stability Analysis results. Figure 4-1 shows the response of GEN-2008-023 during a three-phase fault (FLT03-3PH) during winter peak conditions. Figures 4-2 and 4-3 show selected bus voltages in the study area during FLT03-3PH, which is a representative case for the “worst” delayed voltage recovery. Figure 4-4 shows the response of GEN-2008-023 during a three-phase fault on the low-side of the Elk City 138/230 kV transformer (FLT30-3PH) during winter peak conditions. Figures 4-5 and 4-6 show selected bus voltages in the study area during FLT30-3PH, which is a representative case for the “worst” voltage dips.

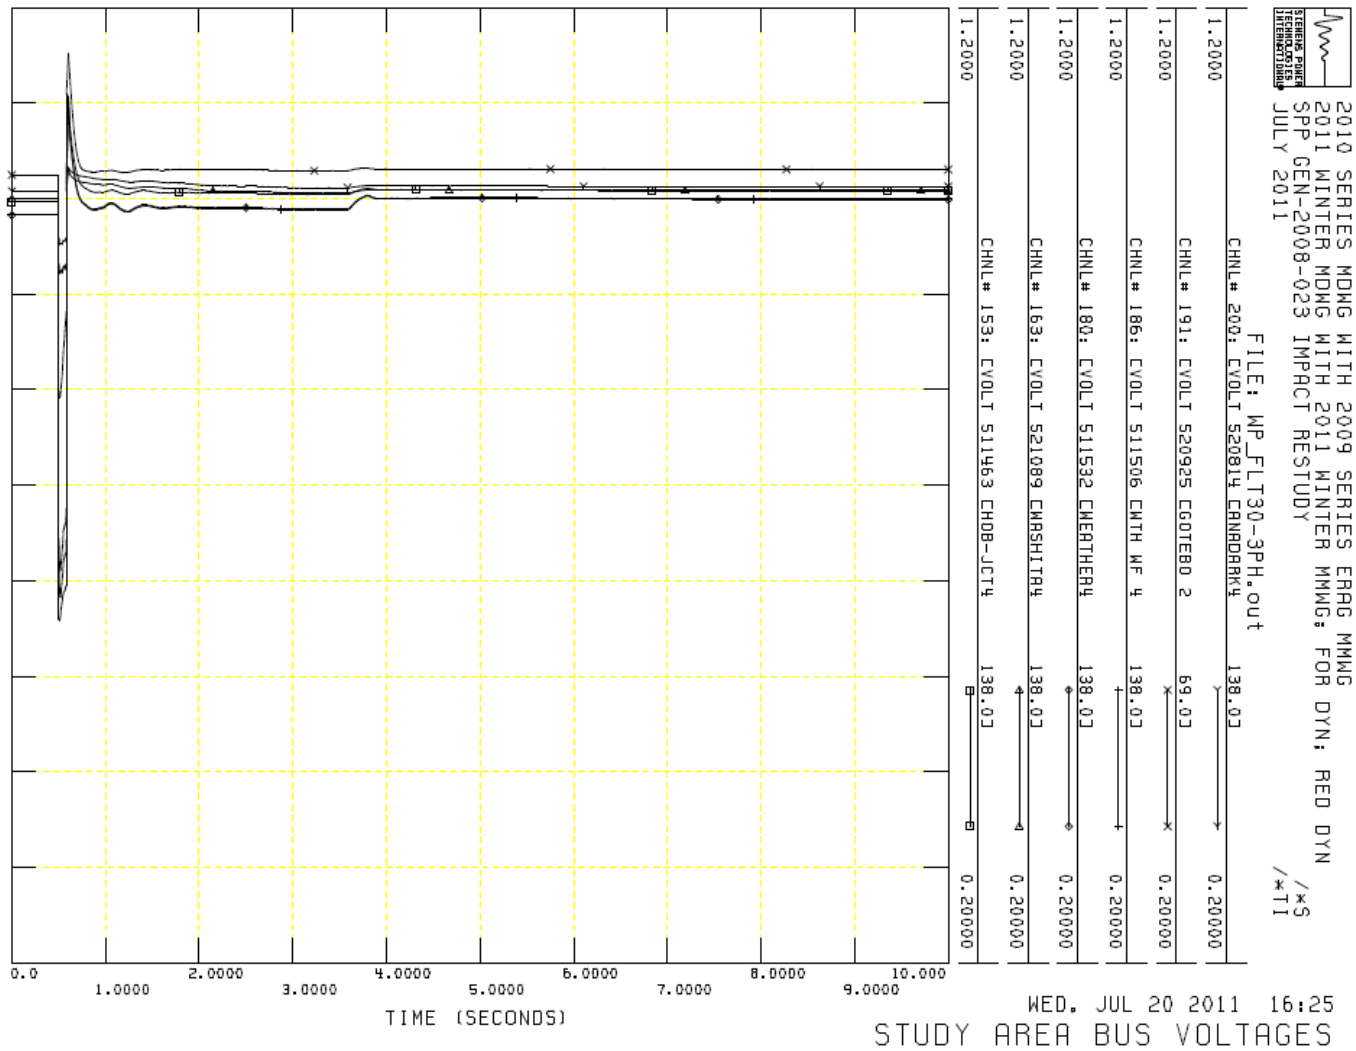
Figure 4-5. Response of selected area bus voltages for case FLT30-3PH for winter peak conditions.
