**GEN-2010-005**  
Impact Restudy for  
Generator Modification

Published January 2020  
By SPP Generator Interconnections Dept.

## **A: CONSULTANT'S MATERIAL MODIFICATION STUDY REPORT**

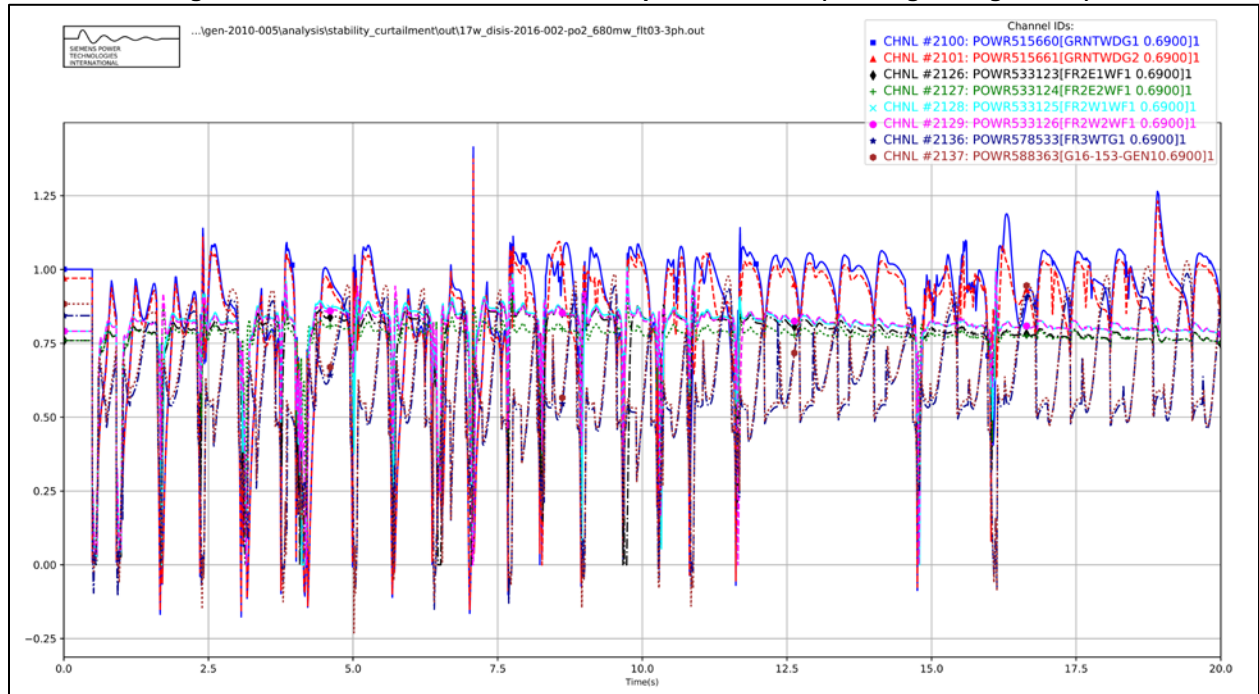
Figure 5-1 and Figure 5-2 show the GEN-2010-005 response during the FLT03-PO2 event in the 2017WP case for the existing GEN-2010-005 Phase II configuration and the modified GEN-2010-005 Phase II configuration respectively.

**Figure 5-1: FLT03-PO2 GEN-2010-005 Response 2017WP (Existing Configuration)**

FLT03-PO2, the prior outage on the Viola POI bus to Wichita 345 kV line, followed by a three-phase fault on and loss of the Renfrow to Hunter 345 kV line, would cause GEN-2010-005 to become unstable in the 2017WP case. This unstable response was only observed in the 2017WP case, and not the 2018SP and 2026SP cases. This is because the 2018SP and 2026SP cases included upgrades at and connected to the Viola 345/138 kV Substation, which have been in service since April 19, 2018 but were not modeled in the 2017WP case.
