Aeneden
Consulting

GEN-2011-010 and GEN-2014-005
Modification Request Impact Study

Revision R1

Date of Submittal
June 18, 2021

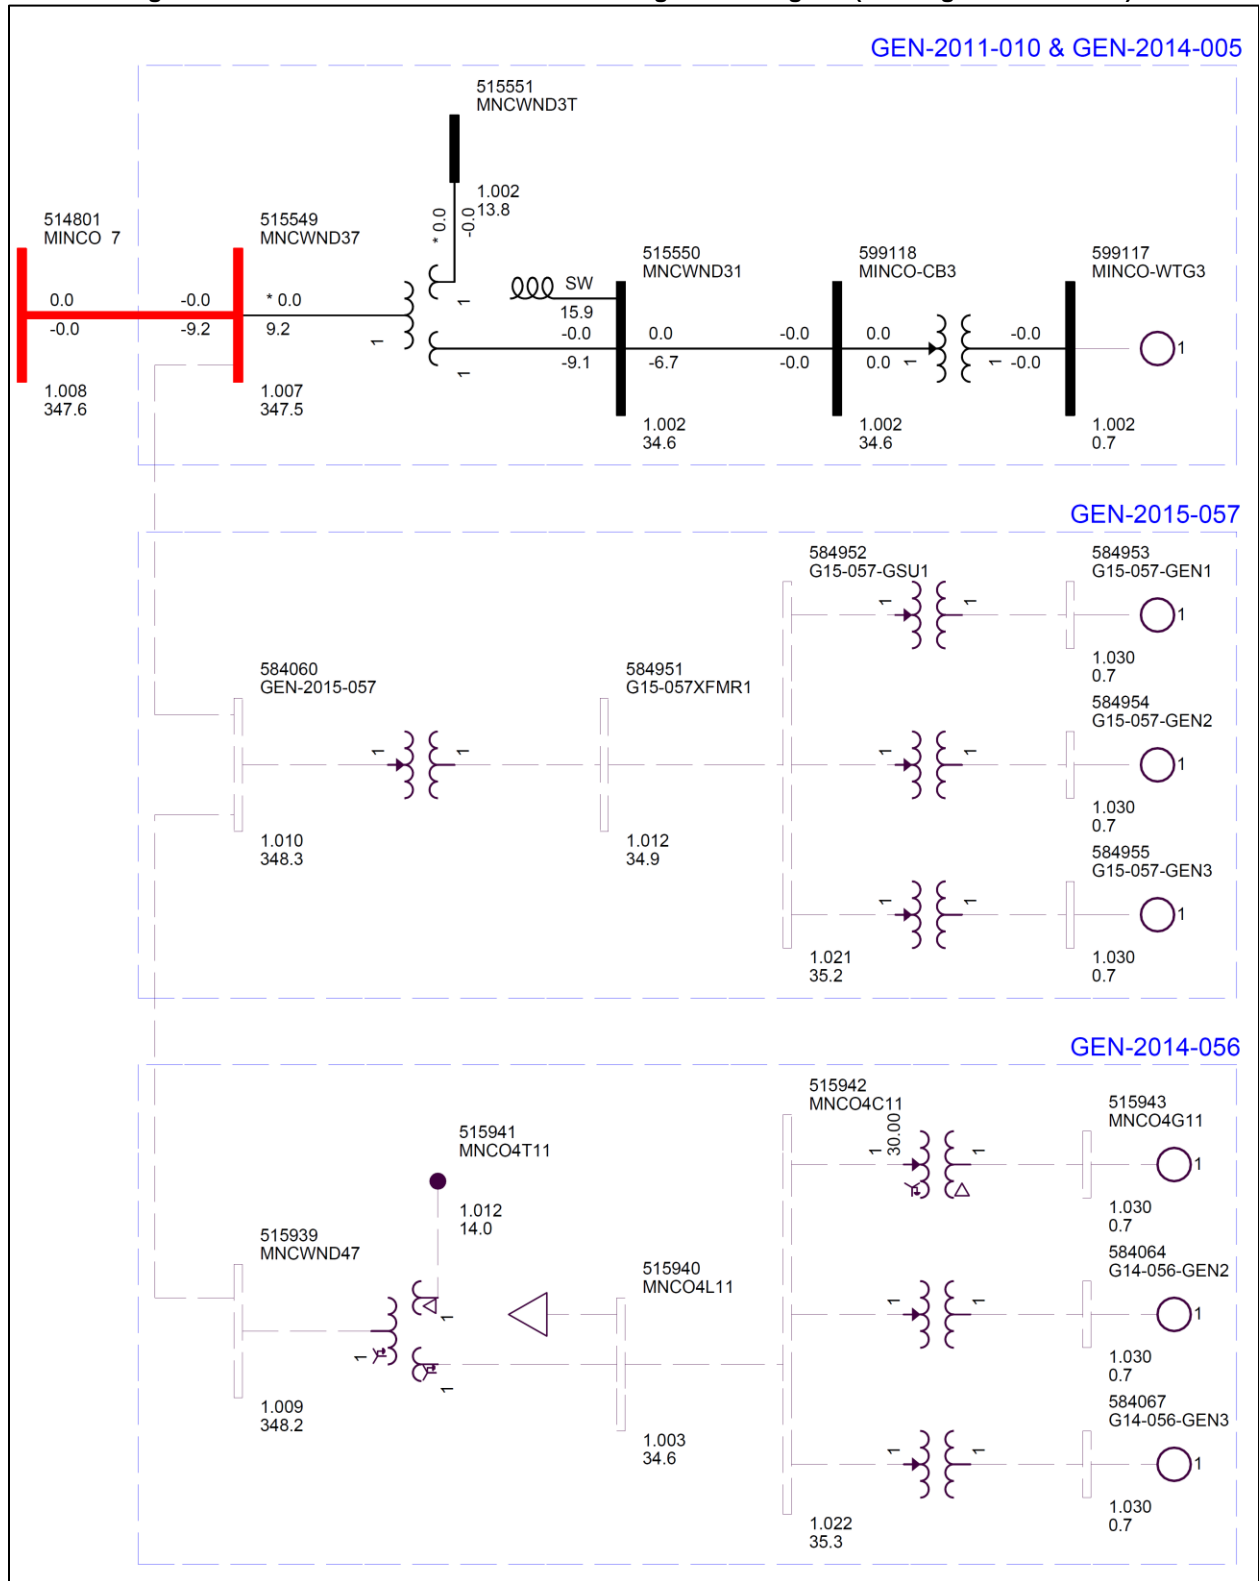
Figure 4-1: GEN-2011-010 & GEN-2014-005 Single Line Diagram (Existing Shunt Reactor)

The results from the analysis showed that the GEN-2011-010 and GEN-2014-005 project needed approximately 14.74 MVAr of compensation at its project substation, to reduce the POI MVAr to zero. This is a decrease from the 15.8 MVAr found for the existing GEN-2011-010 and GEN-2014-005 configuration. Figure 4-1 illustrates the shunt reactor size needed to reduce the POI MVAr to approximately zero with the existing configuration. Figure 4-2 illustrates the shunt reactor size needed to reduce the POI MVAr to approximately zero with the updated topology. The final shunt reactor requirements for GEN-2011-010 and GEN-2014-005 are shown in Table 4-1.
