GEN-2015-021
Impact Restudy for
Generator Modification
(Inverter Change)

The GEN-2015-021 Interconnection Customer has requested a modification to its Generator Interconnection Request to change from twenty (20) AE 1000NX 1MW solar inverters to five (5) GE LV5 4MVA solar inverters. The nameplate power remains unchanged at 20MW.

Southwest Power Pool GEN-2015-021 System Impact Restudy for Generator Modification

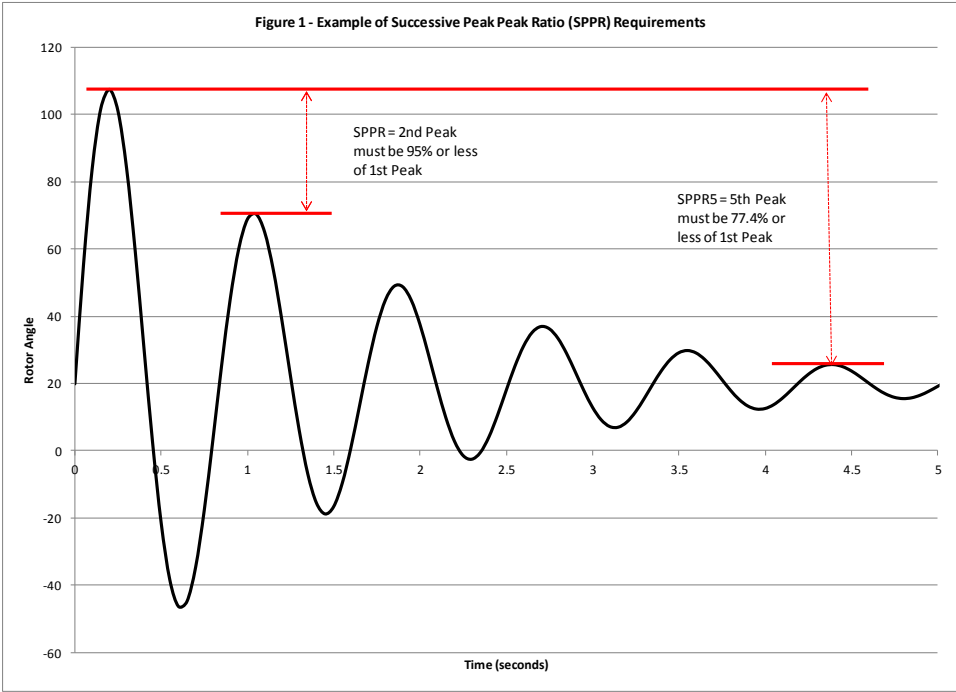
Damping Ratio ≥ 0.0081633

Qualitatively, these Requirements are shown in Figure 1 below.
