**Submitted to  
Southwest Power Pool**

**GEN-2015-082  
Modification Request Impact Study**

Revision R1

Date of Submittal  
September 28, 2020

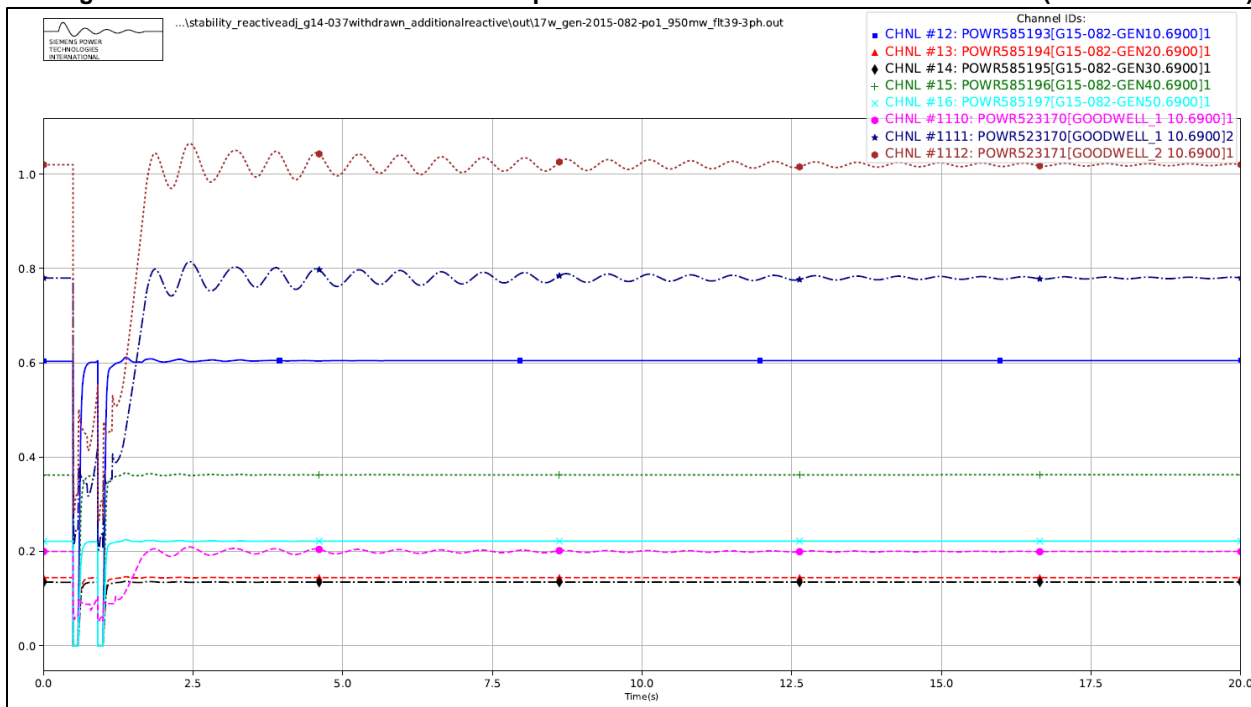
Figure 6-5: FLT39-PO1 GEN-2015-082 Response After Generation Curtailed to 950 MW (17WP MRIS Case)

Figure 6-4 and Figure 6-5 show the updated GEN-2015-082 response to FLT39-PO1 before and after curtailment respectively. Figure 6-6 and Figure 6-7 show the updated GEN-2015-082 response to FLT04-PO3 before and after curtailment respectively.

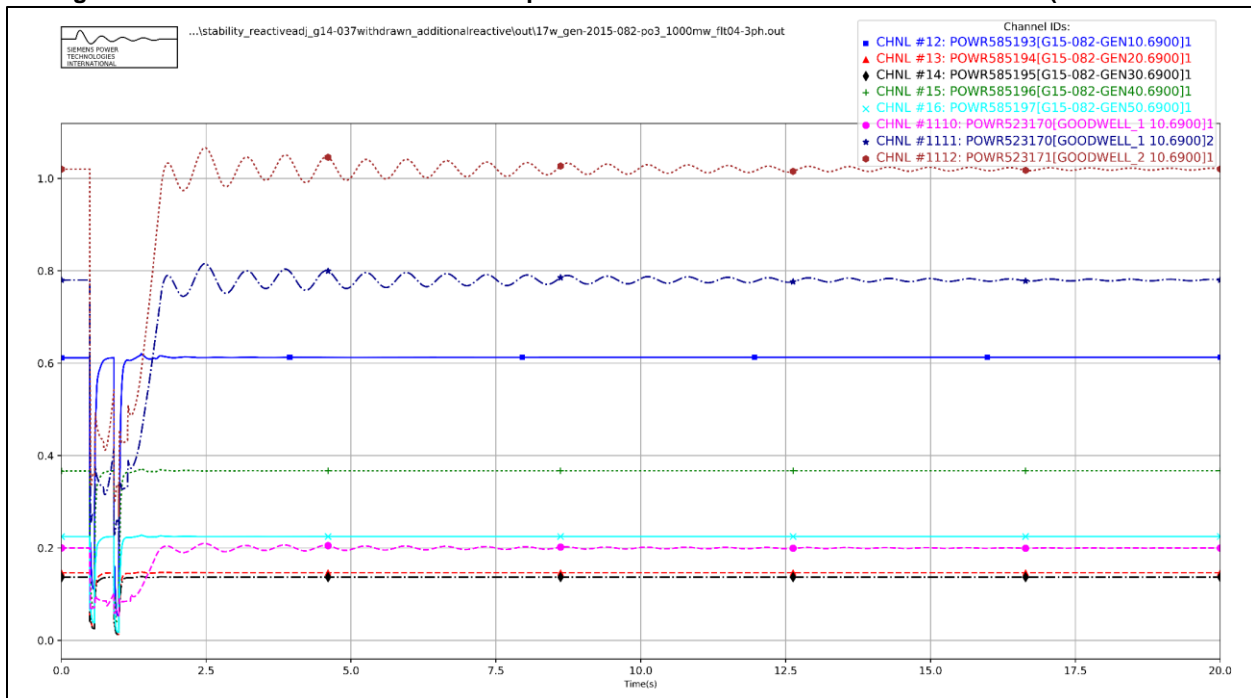
Figure 6-7: FLT04-PO3 GEN-2015-082 Response After Generation Curtailed to 1000 MW (17WP MRIS Case)
