# GEN-2015-025 Modification Request Impact Study

Revision R1 May 8, 2024

Submitted to Southwest Power Pool

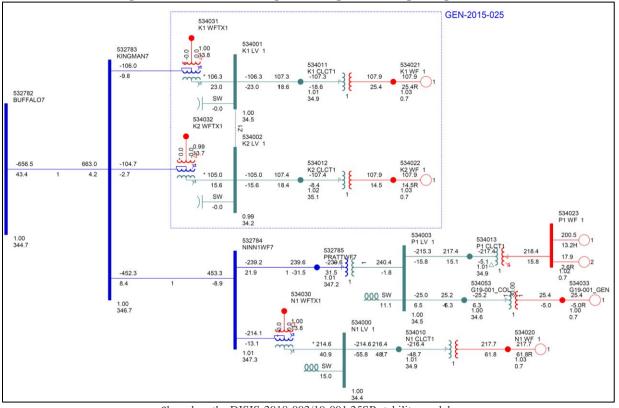
Figure 2-1: GEN-2015-025 Single Line Diagram (Existing Configuration\*)

<sup>\*</sup>based on the DISIS-2018-002/19-001 25SP stability models

The GEN-2015-025 project is currently in the DISIS-2015-001 cluster. Figure 2-1 shows the power flow model single line diagram for the existing GEN-2015-025 configuration using the DISIS-2018-002/19-001 25SP stability model.
