Report on

GEN-2015-052 Modification Request Impact Study

Revision R1 November 6, 2024

Submitted to
Southwest Power Pool

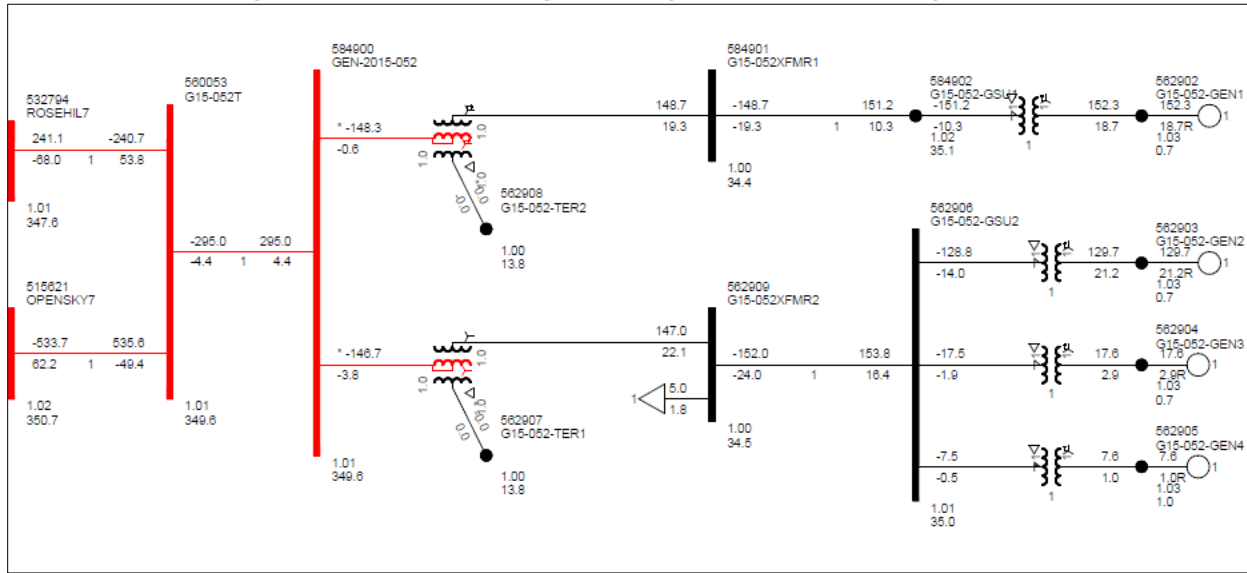
Figure 2-2: GEN-2015-052 Single Line Diagram (Modification Configuration)

This Study has been requested to evaluate the modification of GEN-2015-052 to change the configuration to 100 x GE 2.82 MW + 7 x GE 2.52 MW + 2 x GE 3.8 MW wind turbines with for a total assumed dispatch of 307.24 MW. The turbine generating capability (307.24 MW) exceeds its Generator Interconnection Agreement (GIA) Interconnection Service amount. The injection amount must be limited to 300 MW at the POI as listed in Appendix A of the GIA. As a result, the customer must ensure that the amount of power injected at the POI does not exceed the Interconnection Service amount listed in its GIA. The requested modification includes the use of a Power Plant Controller (PPC) to limit the total power injected into the POI.

In addition, the modification request included changes to the collection system, generator step-up transformers, auxiliary load, and main substation transformers. Figure 2-2 shows the power flow model single line diagram for the GEN-2015-052 modification. The existing and modified configurations for GEN-2015-052 are shown in Table 2-1 below.
