**GEN-2015-089**  
Impact Restudy for  
Generator Modification

Published April 2019  
By SPP Generator Interconnections Dept.

# **A: CONSULTANT'S MATERIAL MODIFICATION STUDY REPORT**

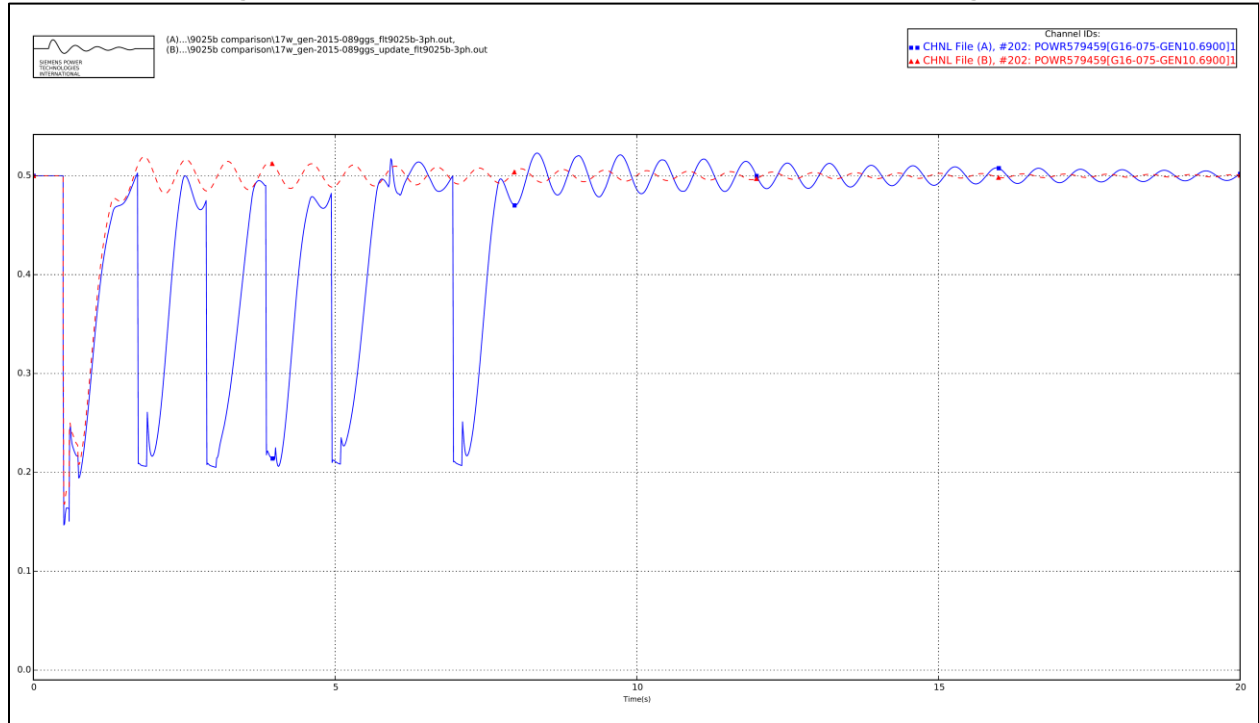
Figure 5-2: FLT9025B-3PH Modification Case with and without Upgrades

Figure 5-2 shows that the instability was mitigated with DISIS-2016-002 identified network upgrades in place.

FLT9025B oscillations was observed in the 17W GGS base case and modification request models. The following previously assigned upgrades that were not included in the base DISIS-2016-002 models used to generate the results shown in Table 5-2 were applied to the 17W GGS model. FLT9025B was then re-simulated with these upgrades in place to see the impact on the system performance:
