GEN-2015-021
Impact Restudy for
Generator Modification

Published August 2019
By SPP Generator Interconnections Dept.

The GEN-2015-021 Interconnection Customer has requested a modification to its 20 MW Interconnection Request. This system impact restudy was performed to determine the effects of changing solar inverters from 5 GE LV5 4 MW inverters (for a total of 20 MW) to 184 Sungrow SG125 0.1075 MW inverters (for a total of 19.78 MW). In addition, the modification request included changes to the collection system and the generator substation transformer. The point of interconnection (POI) for GEN-2015-021 remains at the Johnson Corner 115 kV Substation.

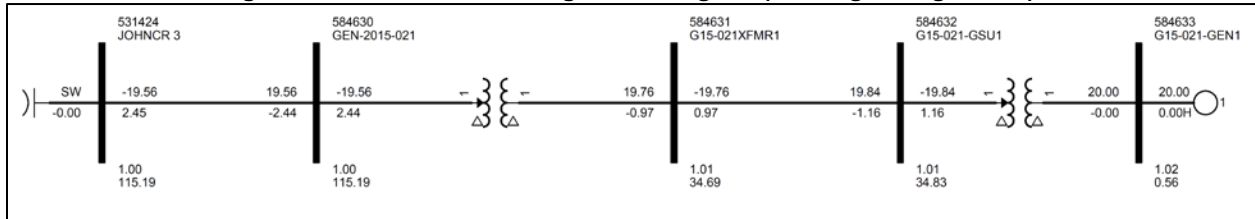
Figure 2-1: GEN-2015-021 Single Line Diagram (Existing Configuration)

GEN-2015-021 was originally studied as part of Group 3 in the DISIS-2015-001 study. Figure 2-1 shows the power flow model single line diagram for the existing GEN-2015-021 configuration.

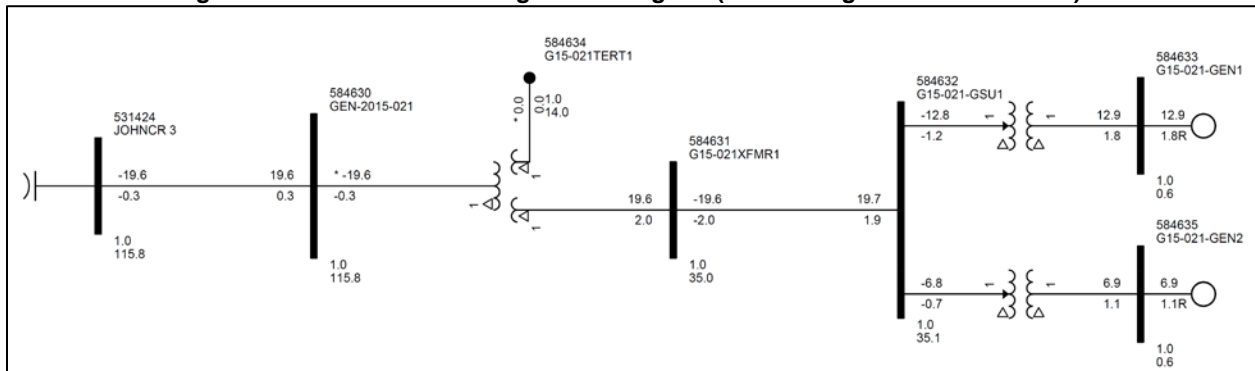
Figure 2-2: GEN-2015-021 Single Line Diagram (New Configuration – 19.78 MW)

The GEN-2015-021 Modification Request included an inverter configuration change to a total of 184 x Sungrow SG125 0.1075MW inverters for a total capacity of 19.78 MW. In addition, the modification request also included changes to the collection system, generation interconnection line and the generator substation transformer. The major modification request changes are shown in Figure 2-2 and Table 2-1 below.

Facility	Existing	Modification Request	
Point of Interconnection	Johnson Corner 115 kV Substation (531424)	Johnson Corner 115 kV Substation (531424)	
Configuration/Capacity	5 x GE LV5 4MW = 20 MW	184 x Sungrow SG125 0.1075MW = 19.78 MW	
Generation Interconnection Line	Length = 0.038 miles R = 0.000090 pu X = 0.000220 pu B = 0.000000 pu	Length = 0.038 miles R = 0.000090 pu X = 0.000220 pu B = 0.000000 pu	
Main Substation Transformer	Z = 5.7%, Winding 15 MVA, Rating A 20 MVA, Rating B 25 MVA	Z12 = 7%, Z23 = 2.5%, Z13 = 10.9%, Rating 25 MVA	
GSU Transformer	Gen Equivalent Qty: 5 Z = 6%, Rating 20 MVA	Gen 1 Equivalent Qty: 120 Z = 5.8%, Rating 15 MVA	Gen 2 Equivalent Qty: 64 Z = 5.74%, Rating 8 MVA
Equivalent Collector Line	R = 0.020780 pu X = 0.006760 pu B = 0.002120 pu	R = 0.012879 pu X = 0.003865 pu B = 0.001391 pu

Following the completion of the modification request study for the changes shown in Figure 2-2 and Table 2-1, the interconnection customer requested an additional adjustment to the capacity of the generators from the 184 inverters at 0.1075 MW (19.78 MW) to approximately 184 inverters at 0.1087 MW (20.00 MW). This additional change is reflected in Figure 2-3 and Table 2-2 below.

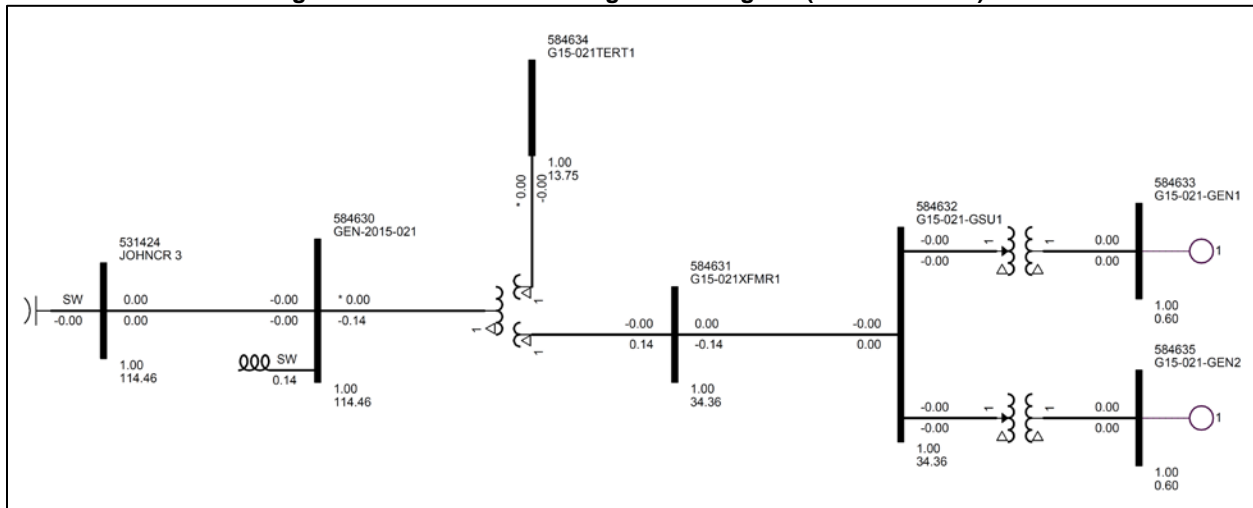
Figure 3-1: GEN-2015-021 Single Line Diagram (Shunt Reactor)

The results from the reactive power analysis showed that the GEN-2015-021 projects required approximately 0.14 MVAR shunt reactance at the high side of the project substation, to reduce the POI MVAR to zero. This represents the contributions from the project collection system. Figure 3-1 illustrates the shunt reactor size required to reduce the POI MVAR to approximately zero. Reactive compensation can be provided either by discrete reactive devices or by the generator itself if it possesses that capability.

The results of the reactive power analysis, also known as the low or reduced generation analysis, performed using the three main models showed that the GEN-2015-021 project may require a 0.14 MVAR shunt reactor on the 115kV bus of the project substation. The shunt reactor is needed to reduce the reactive power transfer at the POI to approximately zero during low/no irradiance conditions while the generation interconnection project remains connected to the grid.

Table 3-1 shows the shunt reactor size determined for the three study models used in the assessment.
