**GEN-2015-034 &
GEN-2016-022**

Impact Restudy for
Generator Modification
(Turbine Change)

Published July 2019
By SPP Generator Interconnections Dept.

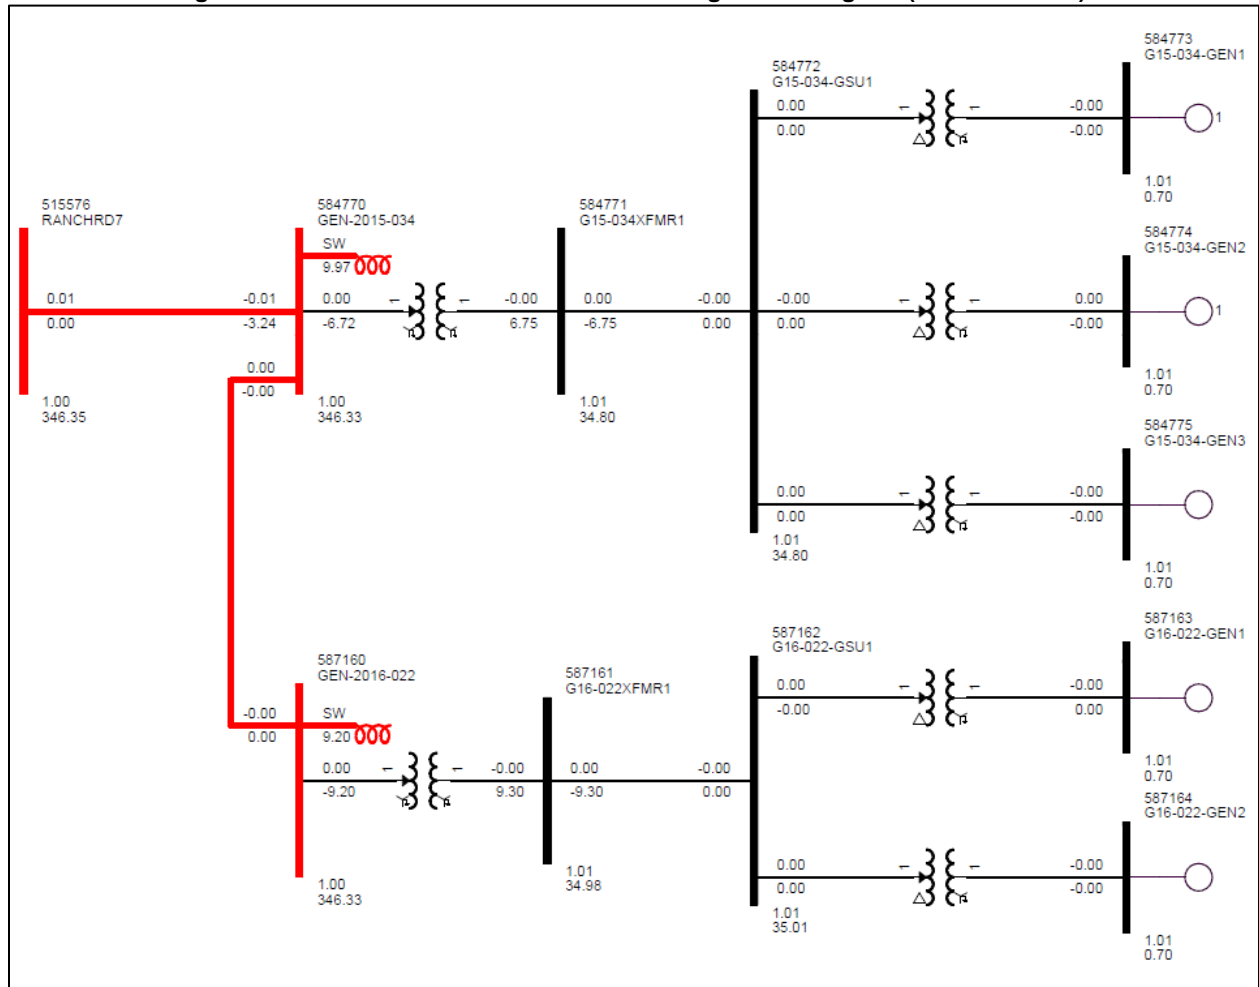
The results from the reactive power analysis showed that the GEN-2015-034 and GEN-2016-022 project required approximately 9.89 MVAR and 9.13 MVAR respectively for shunt reactance at the high side buses of each project substation, to reduce the POI MVAR to zero. This represents the contributions from the project collector systems. Figure 3-1 illustrates the shunt reactor sizes required to reduce the POI MVAR flow to approximately zero. Reactive compensation can be provided either by discrete reactive devices or by the generator itself if it possesses that capability.

Figure 3-1: GEN-2015-034 & GEN-2016-022 Single Line Diagram (Shunt Reactor)

The results of the reactive power analysis, also known as the low-wind/no-wind condition analysis, performed using all three models showed that the GEN-2015-034 requires a 9.89 MVAR shunt reactor on the 345 kV bus of its project substation and GEN-2016-022 requires a 9.13 MVAR shunt reactor on the 345 kV bus of its project substation. The shunt reactors are needed to reduce the reactive power transfer at the POI to approximately zero during low/no wind conditions while the generation interconnection project remains connected to the grid.

The results of the reactive power analysis, also known as the low-wind/no-wind condition analysis, performed using all three models showed that the combined GEN-2015-034 and GEN-2016-022 project may require a 9.89 MVar and 9.13 MVar sized shunt reactors on the 345 kV bus of the respective project substations. The shunt reactors are needed to reduce the reactive power flow at the POI to approximately zero during low/no wind conditions while the generation interconnection project remains connected to the grid.
