GEN-2015-046
Impact Restudy for
Generator Modification

Published June 2020
By SPP Generator Interconnections Dept.

A: CONSULTANT'S MATERIAL MODIFICATION STUDY REPORT

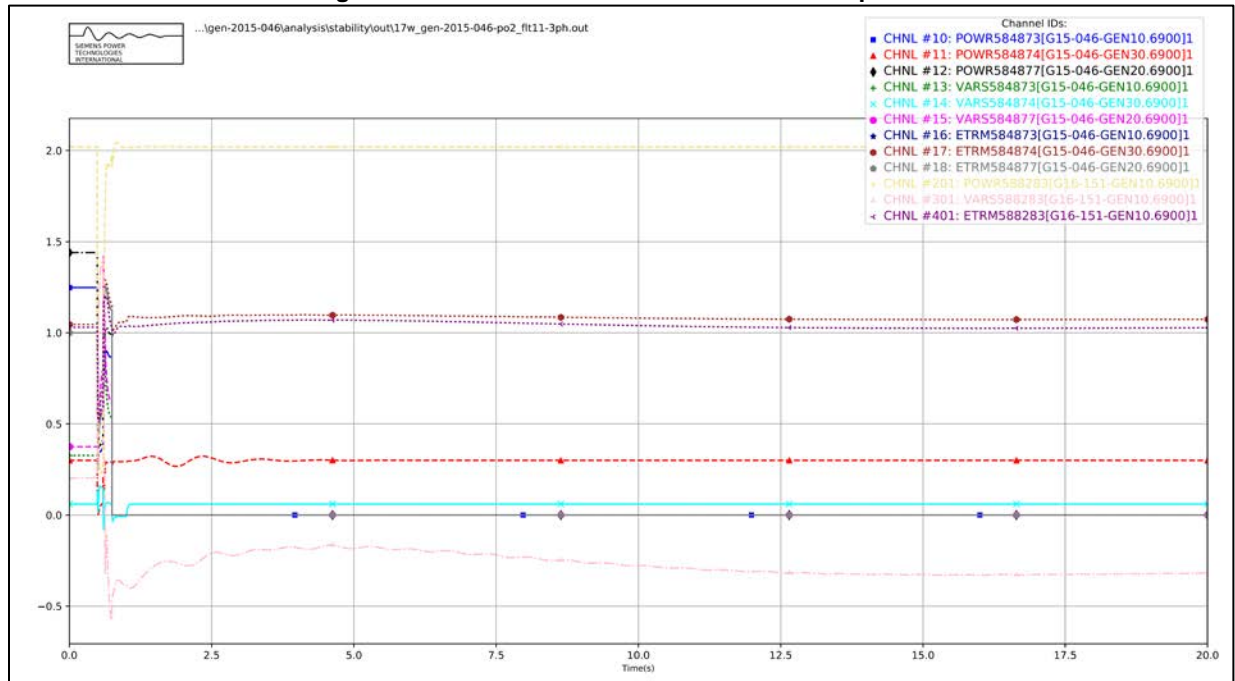
Figure 5-1: FLT11-PO2 GEN-2015-046 Initial Response

Figure 5-1 shows the GEN-2015-046 initial tripping response to FLT11-PO2 and Figure 5-2 shows the stable generator response after GEN-2016-151 was curtailed to 100MW.

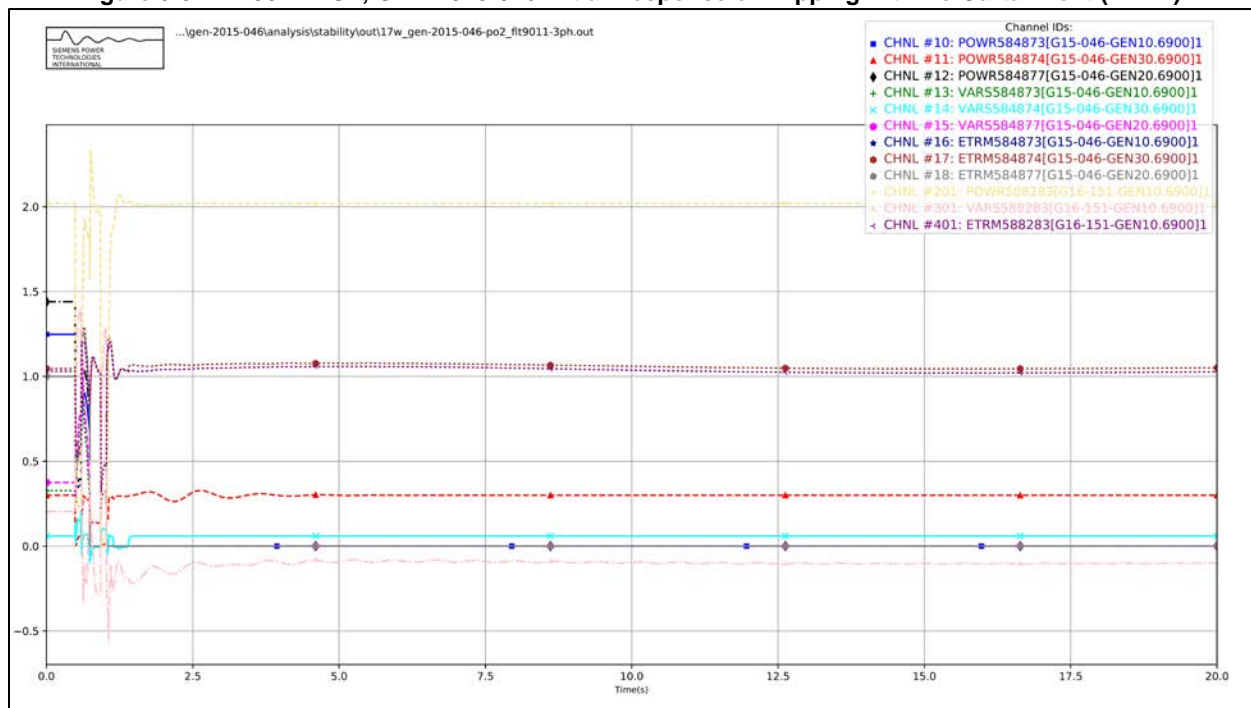
Figure 5-3: FLT9011-PO2; GEN-2015-046 Initial Response of Tripping with No Curtailment (17WP)

Figure 5-3 shows the GEN-2015-046 initial tripping response to FLT9011-PO2 without curtailment, Figure 5-4 shows that GEN-2015-046 is still unstable when GEN-2016-151 and GEN-2015-046 were curtailed by a total curtailment amount of approximately 160 MW, and Figure 5-5 shows the stable system response after GEN-2016-151 and GEN-2015-046 were curtailed by approximately 170 MW in the 2017WP case. The system swing generator was allowed to absorb all generation curtailments.

In addition, for FLT9011-PO2, further curtailment was required to maintain system stability and prevent tripping of GEN-2015-046. Since both GEN-2015-046 and GEN-2016-151 are interconnected to the Tande 345 kV substation, the curtailment was proportionally split between both projects resulting the following curtailment levels after the prior outage on Tande POI bus to Judson 345 kV line as shown in Table 5-4.
