**GEN-2015-064**  
Impact Restudy for  
Generator Modification

Published September 2019  
By SPP Generator Interconnections Dept.

**Aneden**  
Consulting

**Submitted to**  
**Southwest Power Pool**

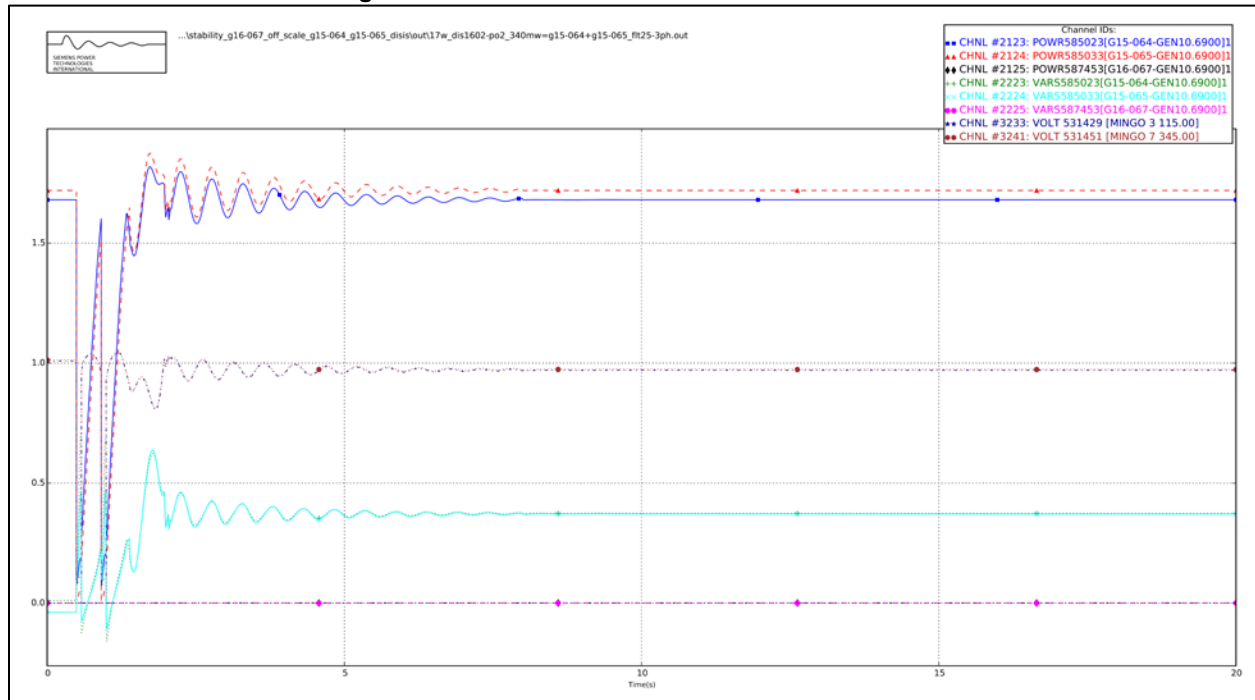
Figure 5-3: FLT25-PO2 Base Case with Curtailment

Figure 5-3 and Figure 5-4 shows that the effect of the curtailment in the 2017WP model before and after the modification request respectively.

In order to mitigate the instability caused by the FLT25-PO2, a few curtailment scenarios were evaluated with combinations of the GEN-2016-067, GEN-2015-064 and GEN-2015-065 output reductions.

First, the output of the lower-queued project, GEN-2016-067 was evaluated and the results showed that the instability observed during FLT25-PO2 still persisted with GEN-2016-067 switched offline. As a result, GEN-2015-064 and GEN-2015-065 were also curtailed to mitigate the instability.
