Report on

GEN-2016-032 Modification Request Impact Study

Revision R1 | October 31, 2022

Submitted to
Southwest Power Pool

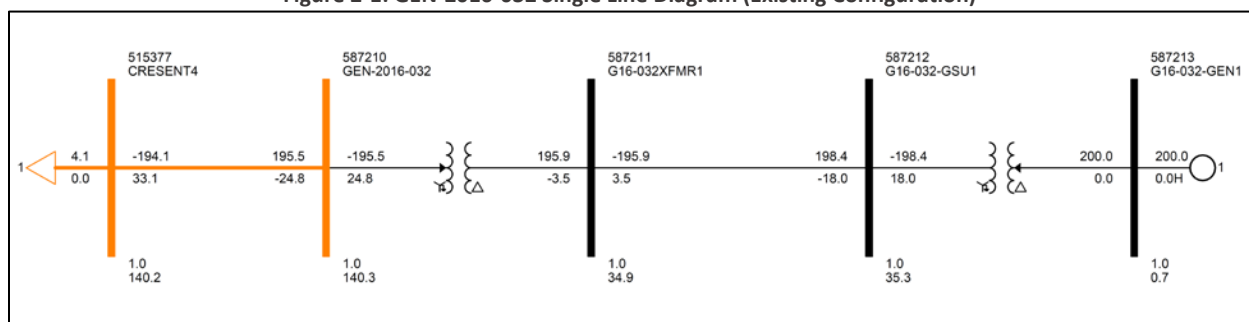
Figure 2-1: GEN-2016-032 Single Line Diagram (Existing Configuration)

Request	Point of Interconnection	Existing Generator Configuration	Interconnection Queue Capacity (MW)
GEN-2016-032	Crescent 138 kV (515377)	100 x Vestas V110 2.0 MW	200

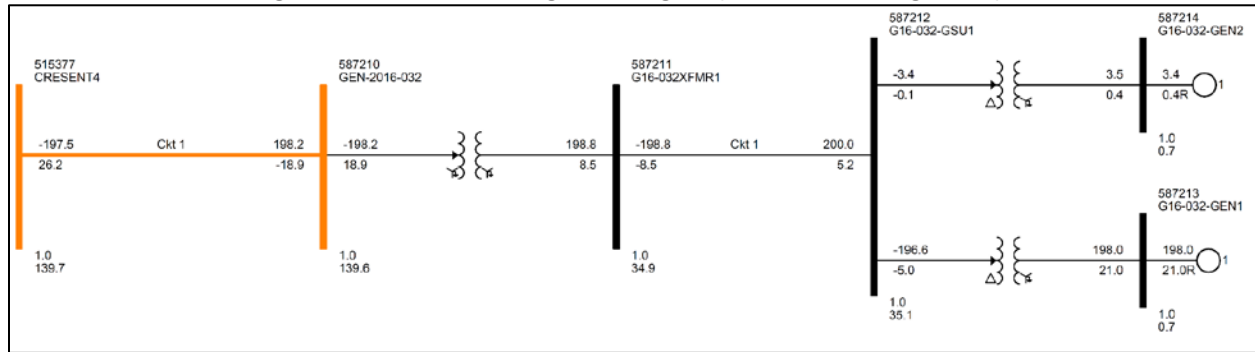
Figure 2-2: GEN-2016-032 Single Line Diagram (Modification Configuration)

This Study has been requested by the Interconnection Customer to evaluate the modification of GEN-2016-032 to a turbine configuration of 33 x Vestas V162 6.0 MW + 1 x Vestas V136 3.45 MW for a total capacity of 201.45 MW. The combined generating capacity for GEN-2016-032 (201.45 MW) exceeds the total Generator Interconnection Agreement (GIA) Interconnection Service amount, (200 MW), as listed in Appendix A of the GIA. As a result, the customer must ensure that the amount of power injected at the POI does not exceed the Interconnection Service amount listed in its GIA. In addition, the modification request included changes to the collection system, generator step-up transformers, generation interconnection line, and main substation transformers. Figure 2-2 shows the power flow model single line diagram for this GEN-2016-032 modification request. The existing and modified configurations for GEN-2016-032 are shown in Table 2-2.

Facility	Existing Configuration	Modification Configuration	
Point of Interconnection	Crescent 138 kV Substation (515377)	Crescent 138 kV Substation (515377)	
Configuration/Capacity	100 x Vestas V110 2.0 MW = 200 MW	33 x Vestas V162 6.0 MW + 1 x Vestas V136 3.45 MW = 201.45 MW POI limited to 200 MW	
Generation Interconnection Line	Length = 6 miles R = 0.003721 pu X = 0.023919 pu B = 0.006482 pu Rating MVA = 217 MVA	Length = 6.96 miles R = 0.001813 pu X = 0.021285 pu B = 0.009850 pu Rating MVA = 217 MVA	
Main Substation Transformer ¹	X = 8.497%, R = 0.188%, Winding MVA = 150 MVA, Rating MVA = 250 MVA	X = 9.498%, R = 0.209%, Winding MVA = 134 MVA, Rating [A/B] MVA = 134/223.8 MVA	
Equivalent GSU Transformer ¹	Gen 1 Equivalent Qty: 100 X = 9.759%, R = 0.895%, Winding MVA = 206 MVA, Rating MVA = 206 MVA	Gen 1 Equivalent Qty: 33 X = 10.299%, R = 0.9%, Winding MVA = 240.9 MVA, Rating MVA = 240.9 MVA	Gen 2 Equivalent Qty: 1 X = 8.999%, R = 0.8%, Winding MVA = 4.0 MVA, Rating MVA = 4.0 MVA

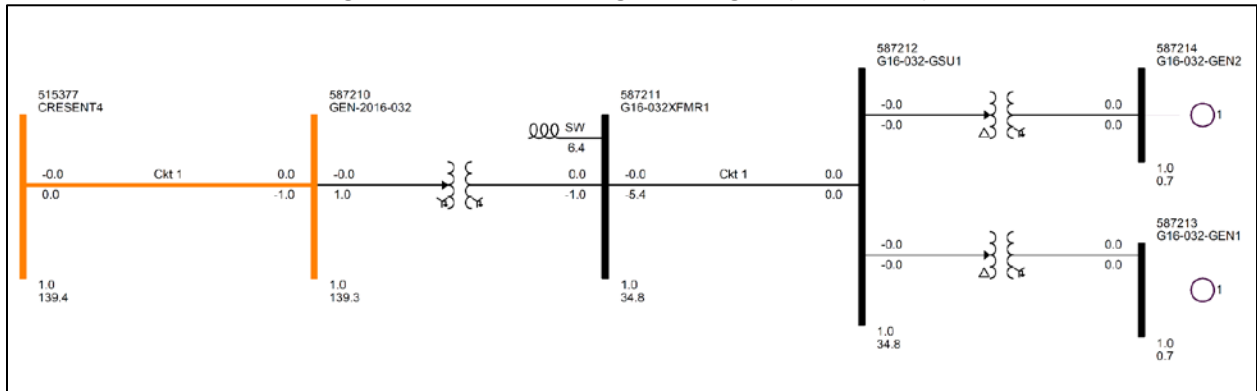
Figure 4-1: GEN-2016-032 Single Line Diagram (Modification)

The results from the analysis showed that the GEN-2016-032 project needed approximately 6.3 MVAR of compensation at its project substation, to reduce the POI MVAR to zero. This is a decrease from the 18.6 MVAR found for the GEN-2016-032 configuration in the previous modification study⁴. Figure 4-1 illustrates the shunt reactor size needed to reduce the POI MVAR to approximately zero with the updated topology. The final shunt reactor requirements for GEN-2016-032 are shown in Table 4-1.

The results of the charging current compensation analysis performed using the 2019 Winter Peak, 2021 Light Load, 2021 Summer Peak, and 2028 Summer Peak models showed that the GEN-2016-032 project needed 6.3 MVAR of reactor shunts on the 34.5 kV bus of the project substation with the modifications in place, a decrease from the 18.6 MVAR found for the GEN-2016-032 configuration in the previous modification study². This is necessary to offset the capacitive effect on the transmission network caused by the project's transmission line and collector system during low-wind or no-wind conditions. The information gathered from the charging current compensation analysis is provided as information to the Interconnection Customer and Transmission Owner (TO) and/or Transmission Operator. The applicable reactive power requirements will be further reviewed by the Transmission Owner and/or Transmission Operator.

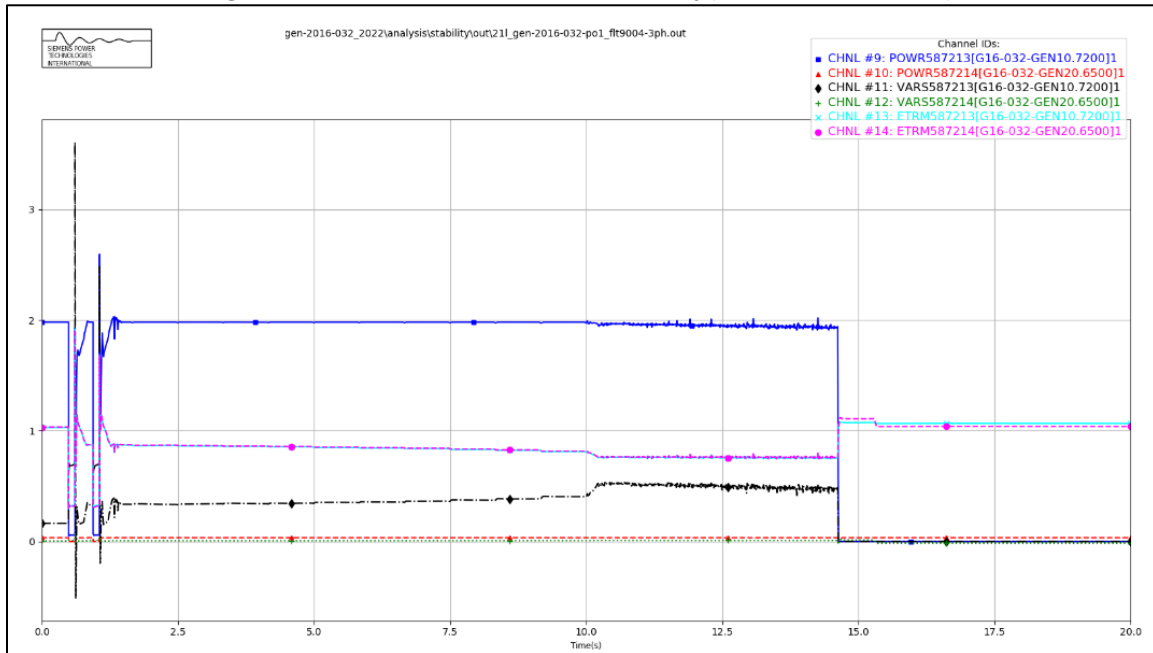
Figure 6-1: FLT9004-PO1 GEN-2016-032 Instability (21LL Modification Case)

(1) FLT9004-PO1 causes GEN-2016-032 instability and tripping. GEN-2016-032 was curtailed to 190MW in the 21LL model to mitigate the instability.

FLT9004-PO1 is categorized as a NERC TPL-001-4 Planning Event P6, which allows for curtailment of firm transmission as a system adjustment as a corrective action following the loss of the first facility. GEN-2016-032 may have to be curtailed to about 190 MW after the prior outage of the Crescent to Cottonwood 138 kV or Twin Lake to Dover 138 kV, to remain stable following a subsequent fault. Figure 6-1 shows the GEN-2016-032 instability during FLT9004-PO1 in the 21LL modification case. The stable generator response after being curtailed to 190 MW is shown in Figure 6-2.
