# GEN-2016-087 Modification Request Impact Study

Revision R1 June 2, 2025

Submitted to Southwest Power Pool

Aneden Consulting (Aneden) was retained by the Southwest Power Pool (SPP) to perform a Modification Request Impact Study (Study) for GEN-2016-087, an active Generation Interconnection Request (GIR) with a Point of Interconnection (POI) at the Campbell County 230 kV Substation.

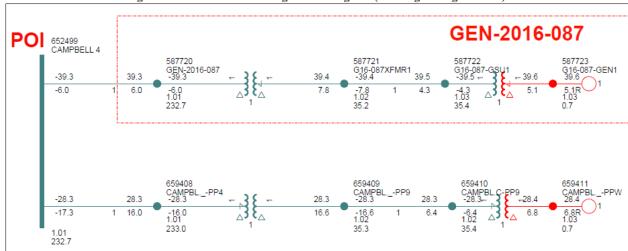
Figure 2-1: GEN-2016-087 Single Line Diagram (Existing Configuration\*)

The GEN-2016-087 project is currently in the DISIS-2016-002 cluster. Figure 2-1 shows the power flow model single line diagram for the existing GEN-2016-087 configuration using the DISIS-2021-001 25SP stability model.

\*based on the DISIS-2021-001 25SP stability models

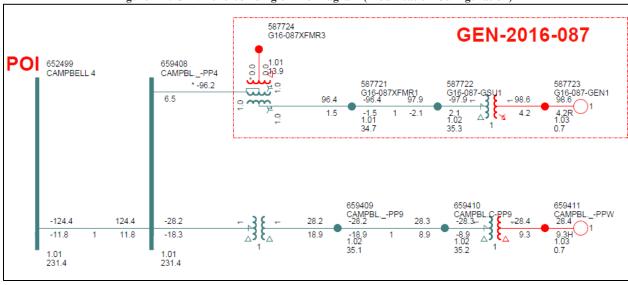
Figure 2-2: GEN-2016-087 Single Line Diagram (Modification Configuration)

In addition, the modification request included changes to the collection system, generator step-up transformers, and main substation transformers. Figure 2-2 shows the power flow model single line diagram for the GEN-2016-087 modification. The existing and modified configurations for GEN-2016-087 are shown in Table 2-1 below.

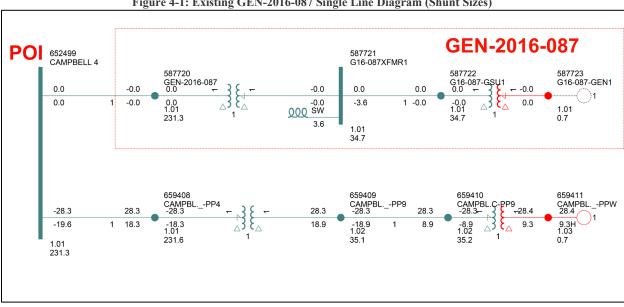
Figure 4-1: Existing GEN-2016-087 Single Line Diagram (Shunt Sizes)

The results from the analysis showed that the GEN-2016-087 project needed approximately 5.3 MVAr of compensation at its collector substation to reduce the MVAr injection at the POI to zero. This is an increase from the 3.6 MVAr found for the existing configuration. The final shunt reactor requirements are shown in Table 4-1. Figure 4-1 illustrates the shunt reactor size needed to reduce the POI MVAr to approximately zero with the existing configuration. Figure 4-2 illustrates the shunt reactor size needed to reduce the POI MVAr to approximately zero with the updated topology.
