# **GEN-2016-032**

## Impact Restudy for Generator Modification (POI Change)

Published November 2019

By SPP Generator Interconnections Dept.

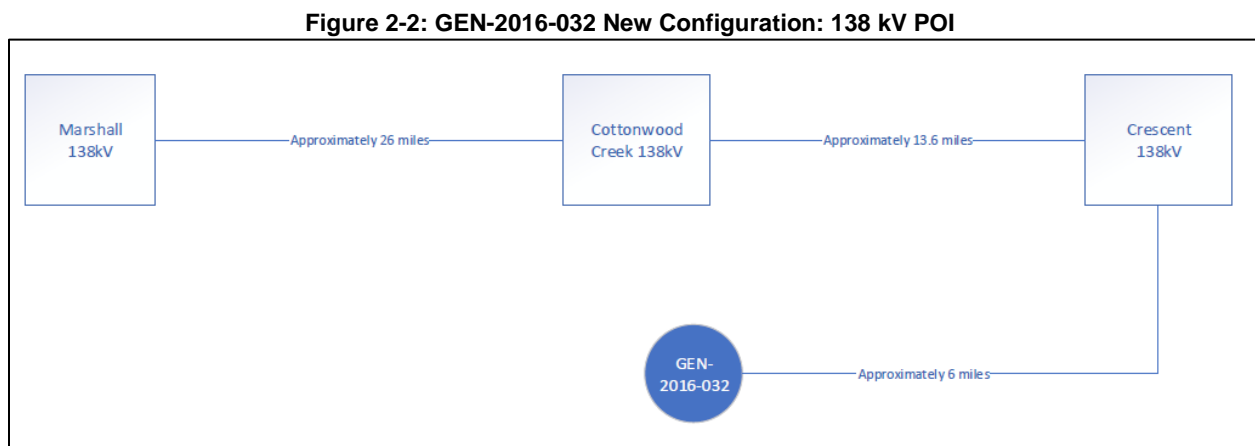
Figure 2-2 shows the configuration of the Modification Request Crescent 138 kV POI change. This POI change moved the GEN-2016-032 to the Crescent 138 kV Substation.

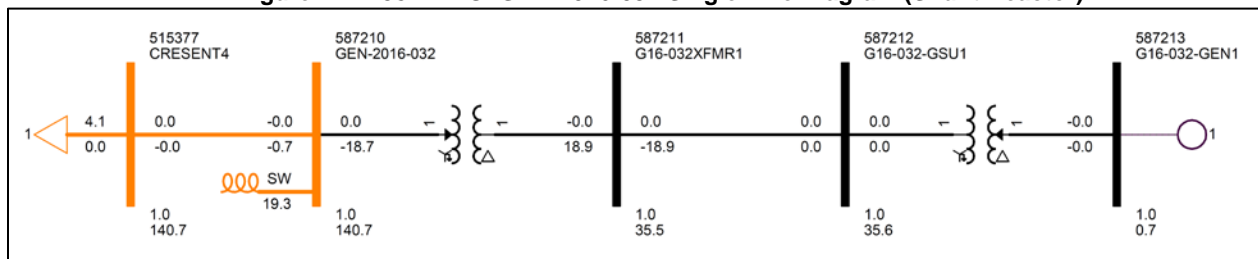
Figure 4-1: 138 kV POI GEN-2016-032 Single Line Diagram (Shunt Reactor)

The results from the reactive power analysis showed that the GEN-2016-032 project required an approximately 18.6 MVar shunt reactor at the project substation, to reduce the POI MVar to zero. Figure 4-1 illustrates the shunt reactor size required to reduce the POI MVar to approximately zero. Reactive compensation can be provided either by discrete reactive devices or by the generator itself if it possesses that capability.

The reactive power analysis, also known as the low-wind/no-wind condition analysis, was performed for the Crescent 138 kV POI for GEN-2016-032 to determine the reactive power contribution from the project’s interconnection line and collector transformer and cables during low/no wind conditions while the project is still connected to the grid and to size shunt reactors that would reduce the project reactive power contribution to the POI to approximately zero.
