**GEN-2016-045 &
GEN-2016-057**
Impact Restudy for
Generator Modification

Published January 2020
By SPP Generator Interconnections Dept.

A: CONSULTANT'S MATERIAL MODIFICATION STUDY REPORT

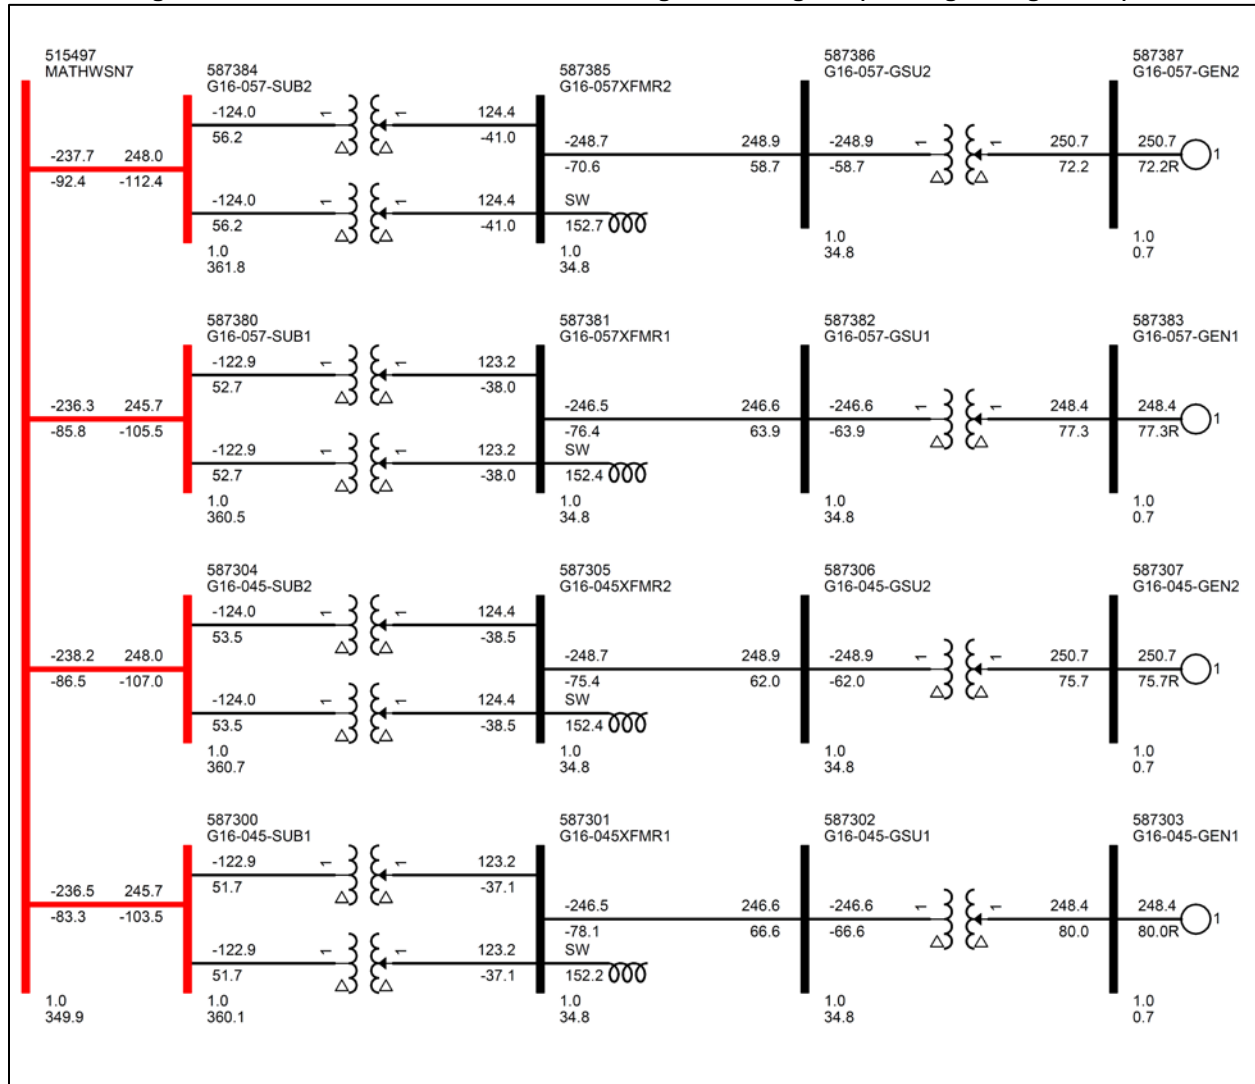
Figure 2-1 shows the power flow model single line diagram for the existing GEN-2016-045 and GEN-2016-057 configurations. GEN-2016-045 and GEN-2016-057 were both originally studied as part of Group 1 in DISIS-2016-001.

Figure 2-1: GEN-2016-045 & GEN-2016-057 Single Line Diagram (Existing Configuration)

Figure 2-1: GEN-2016-045 & GEN-2016-057 Single Line Diagram (Existing Configuration)....	3
Figure 2-2: GEN-2016-045 & GEN-2016-057 Single Line Diagram (New Configuration).....	4
Figure 4-1: GEN-2016-045 & GEN-2016-057 Single Line Diagram (Shunt Reactor).....	11
