**GEN-2016-115**  
Impact Restudy for  
Generator Modification

Published July 2019  
By SPP Generator Interconnections Dept.

## **A: CONSULTANT'S MATERIAL MODIFICATION STUDY REPORT**

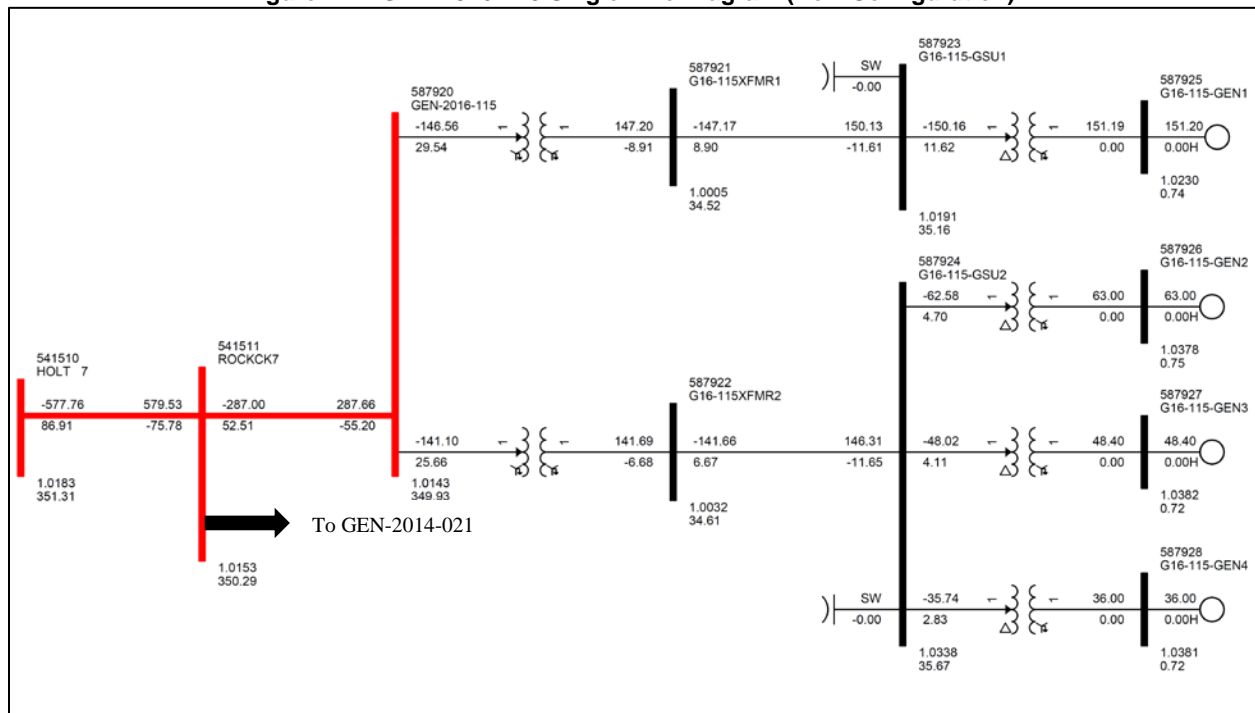
**Figure 2-2: GEN-2016-115 Single Line Diagram (New Configuration)**

The GEN-2016-115 Modification Request included a turbine configuration change to a total of 36 x Vestas V150 4.2 MW (Gen 1) + 15 x Vestas V150 4.2 MW (Gen 2) + 22 x Vestas V120 2.2 MW (Gen 3) + 18 x Vestas V110 2.0 MW (Gen 4) wind turbines for a total capacity of 298.6 MW. In addition, the modification request also included changes to the collection system, generator substation transformer, and generation interconnection line. The major modification request changes are shown in Figure 2-2 and Table 2-1 below.

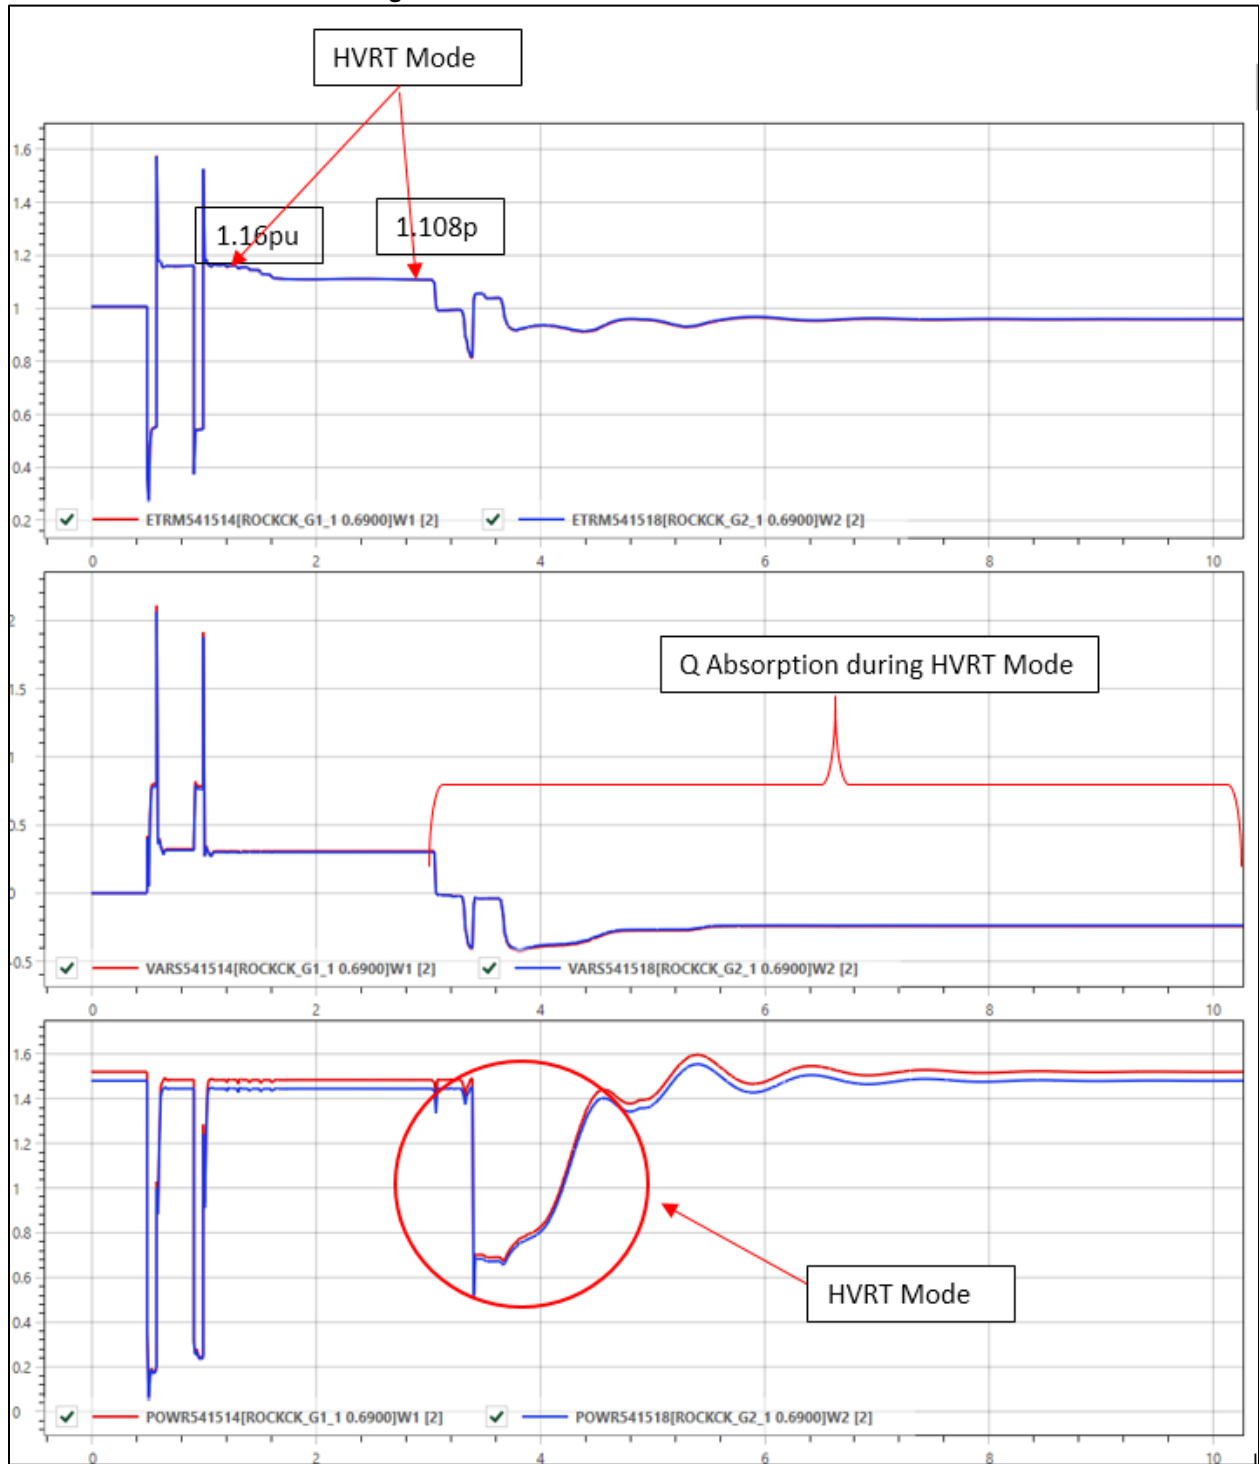
Figure 5-5: GEN-2014-021 HVRT Performance<sup>1</sup>

This turbine power response was communicated with the manufacturer, Vestas, who identified the cause of the power dip as being associated with the wind turbine generator’s (WTG) dynamic model High Voltage Right Through (HVRT) exit voltage parameter (VC18084500 CON J+12). CON (J+12) parameter in the WTG is the voltage value at WTG terminal (0.69kV) at which the turbine exits HVRT Mode. Another parameter *RTPitchRiseLevelIn* is the voltage value at WTG terminal (0.69kV) at which the turbine enters HVRT Mode. While in HVRT mode, the WTG absorbs reactive current.

During the second fault applied after reclosing, the WTG terminal voltage rose to 1.16 pu, entering the HVRT mode (*RTPitchRiseLevelIn* was set to 1.15pu) but the voltage did not settle quick enough so it remained at HVRT Mode for a while. Figure 5-5 shows the WTG terminal voltage at 1.108pu (*RTPitchRiseLevelOut* was set to 1.10 pu), just before the power dip. As a result, the WTG absorbed reactive current/power as shown by the reactive power response on the first graph in Figure 5-5. By increasing the threshold value of HVRT exit voltage (*RTPitchRiseLevelOut*) from 1.10 pu to 1.11pu, the WTG was able to exit the HVRT mode quicker to settle to pre-fault condition.

<sup>1</sup> Vestas provided HVRT plot for 2.0 MW turbine performance
