# GEN-2017-094 Modification Request Impact Study

**Revision R2     January 19, 2023**

Submitted to  
Southwest Power Pool

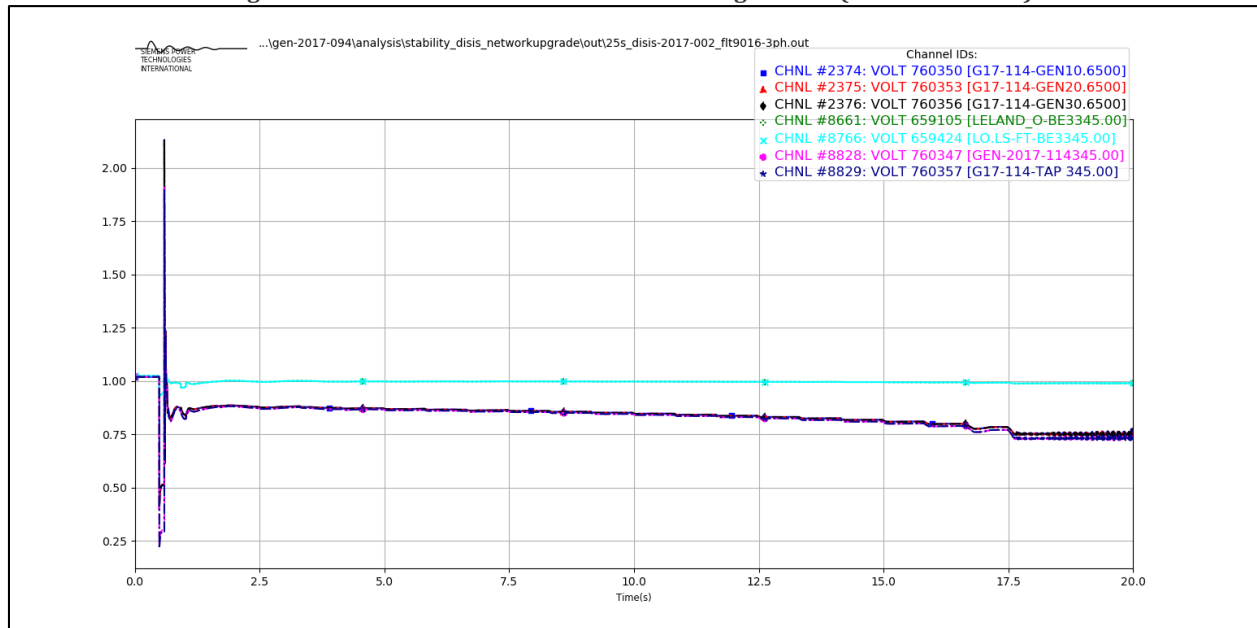
**Figure 6-1: FLT9016-3PH GEN-2017-114 Voltage Issues (25SP DISIS Case)**

The results of the stability analysis showed that FLT9016-3PH, the loss of Chappelle to GEN-2017-114 Tap 345 kV line, caused a low voltage violation and localized voltage collapse at GEN-2017-114. This was observed in the DISIS-2017-002 case without and with the GEN-2017-094 modification as shown in Figure 6-1 and Figure 6-2 respectively. Therefore, the oscillations are not attributed to the GEN-2017-094 modification request. Note that at the time of this Study, the GEN-2017-114 interconnection request was already withdrawn from the SPP Active Queue and as such this issue is no longer relevant.

The results of the dynamic stability analysis showed that there were stability issues associated with GEN-2017-114, an interconnection request withdrawn from the SPP Active Queue. As such that issue is no longer relevant. In addition, oscillations were observed for several generation units including CENTER2G (657748), COYOTE1G (661015), and HESKET3G (661102) under multiple contingencies

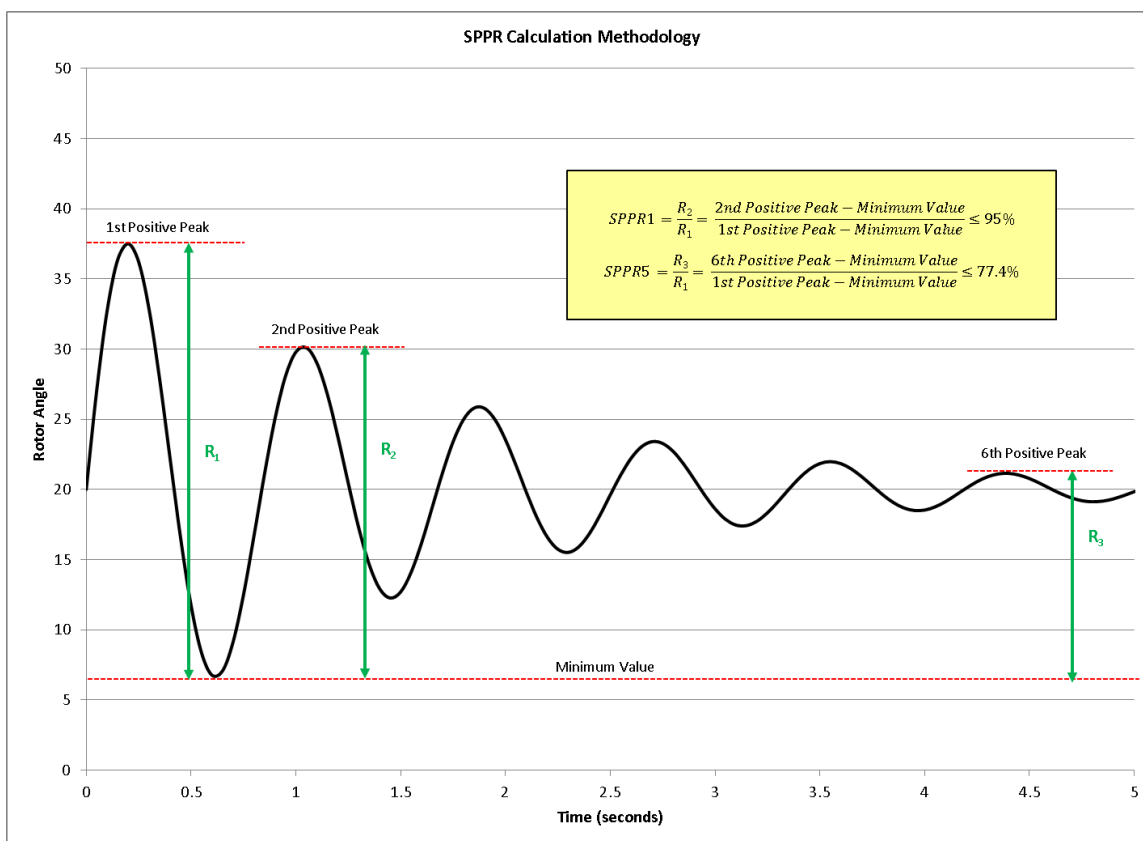
$$\text{Damping Ratio} \geq 0.0081633$$

Qualitatively, these Requirements are shown in Figure 1 & 2 below.
