Report on

GEN-2017-151 Modification Request Impact Study

Revision R1 January 21, 2026

Submitted to
Southwest Power Pool

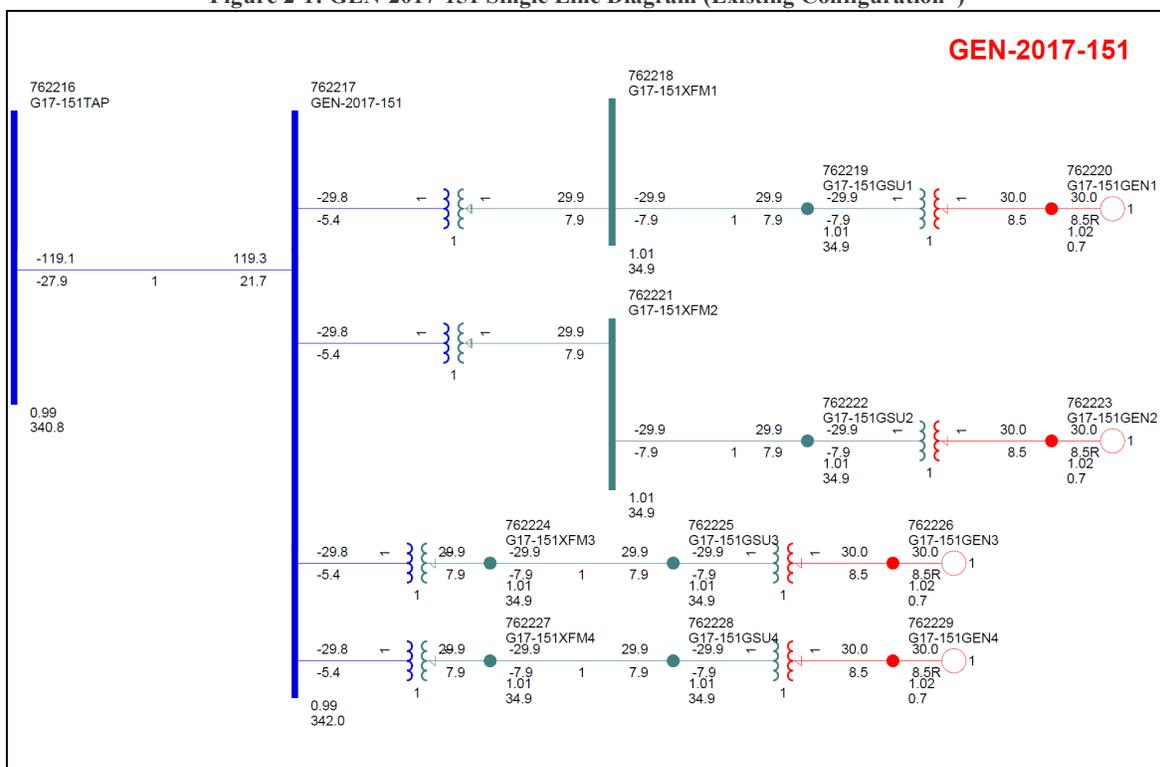
Figure 2-1: GEN-2017-151 Single Line Diagram (Existing Configuration*)

The GEN-2017-151 project is currently in the DISIS-2017-002 cluster. Figure 2-1 shows the power flow model single line diagram for the existing GEN-2017-151 configuration using the DISIS-2021-001 Phase 2 25SP stability model.

*based on the DISIS-2021-001 Phase 2 25SP stability models

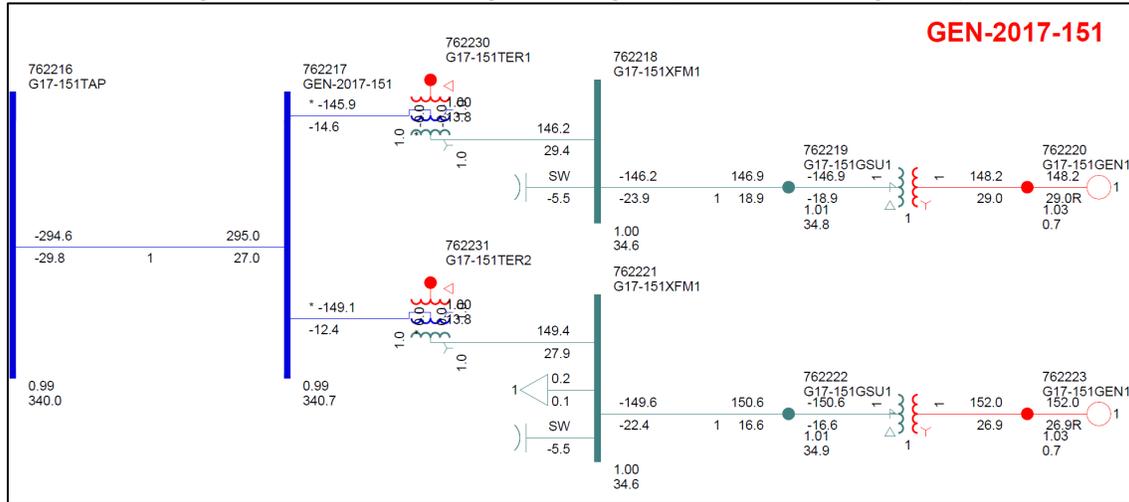
Figure 2-2: GEN-2017-151 Single Line Diagram (Modification Configuration)

This Study has been requested to evaluate the modification of GEN-2017-151 to change the configuration to 79 x GE wind turbines operating at 3.8 MW for a total assumed dispatch of 300.2 MW. The generating capability exceeds its Generator Interconnection Agreement (GIA) Interconnection Service amount, thus the injection amount must be limited to 300 MW at the POI as listed in Appendix A of the GIA. As a result, the customer must ensure that the amount of power injected at the POI does not exceed the Interconnection Service amount listed in its GIA.

In addition, the modification request included changes to the collection system, generation interconnection line, generator step-up transformers, main substation transformers, auxiliary load, and reactive power devices.

Figure 2-2 shows the power flow model single line diagram for the GEN-2017-151 modification. The existing and modified configurations for GEN-2017-151 are shown in Table 2-1 and Table 2-2 below, respectively.
